Limited Assessment of Shoreline Erosion and Industrial Contamination  
at GAC Chemical Corporation

34 Kidder Point Road

Searsport, ME

August 1, 2025

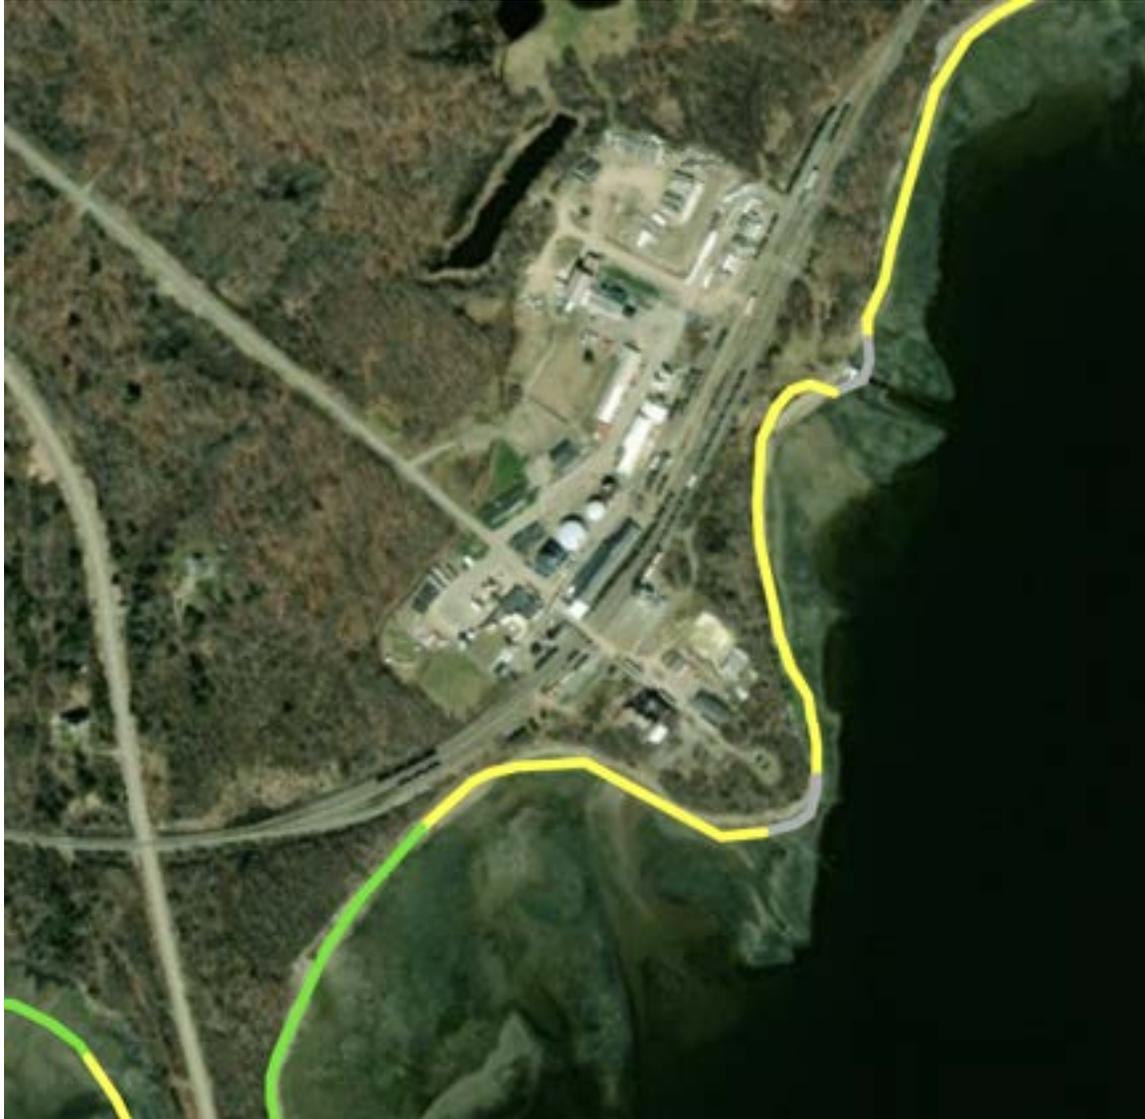
**Figure A3:** Maine Geological Survey (MGS) Coastal Bluffs & Landslide Hazards Map determines;

Sections 1-8: Yellow- Highly Unstable Bluff

Sections 10-18: Yellow- Highly Unstable Bluff

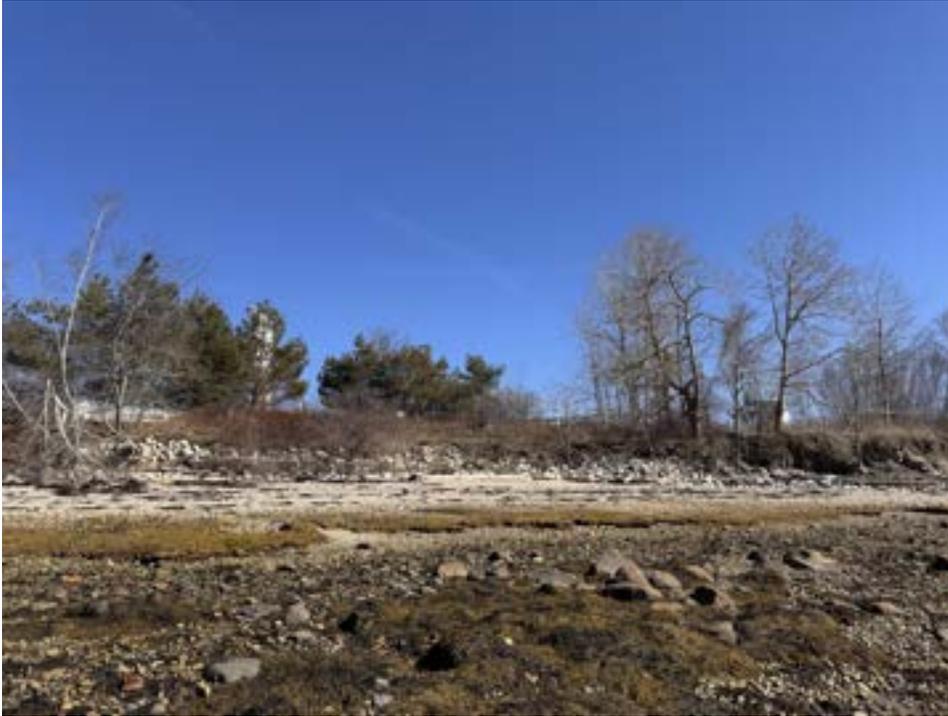
**SECTION 1- 100'**

Photo #1. Overtopped riprap, highly unstable bluff. 44.46478° N, 68.88077° W.

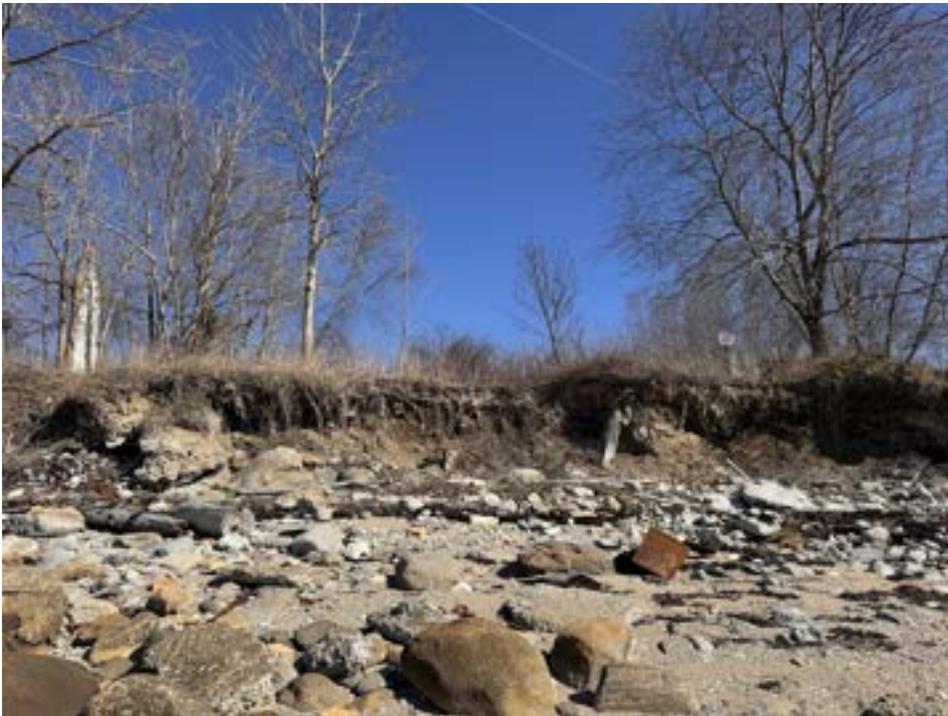
**SECTION 2- 100'**

Photo #2. Highly unstable bluff, metal and concrete waste. 44.46480° N, 68.88035° W

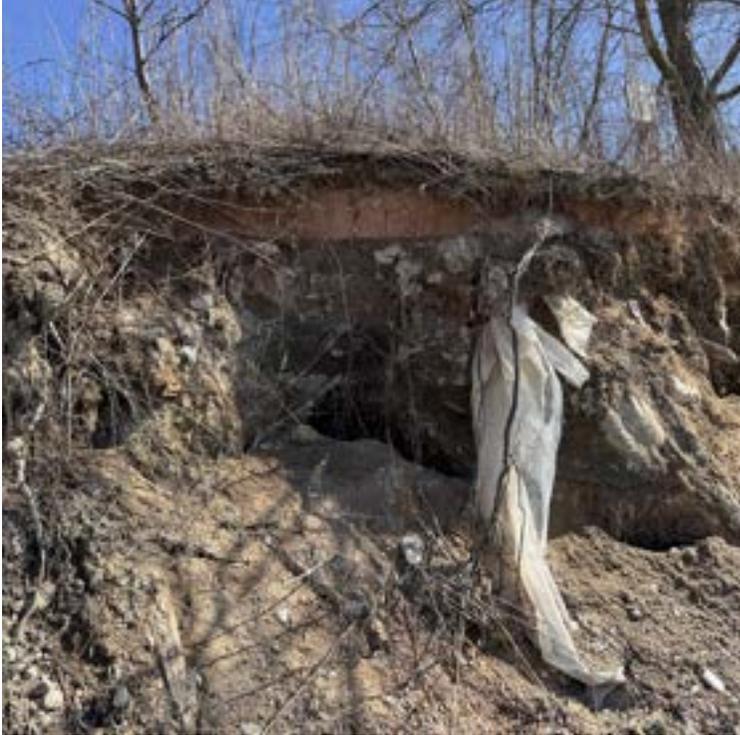
1. A layer of pink-colored sediment/fill, visible in Photo #4 (Attachment B).
2. A reddish layer on intertidal sediments and rocks near an old discharge pipe along the western side of Kidder Point (Photo #6, Attachment B).
3. Multiple locations within Sections 4–6 where a grey, powdery substance is present (Photo #10, Attachment B).

Photo #4. Discolored sediment layer, plastic waste. Direction of View\*\*\*\*

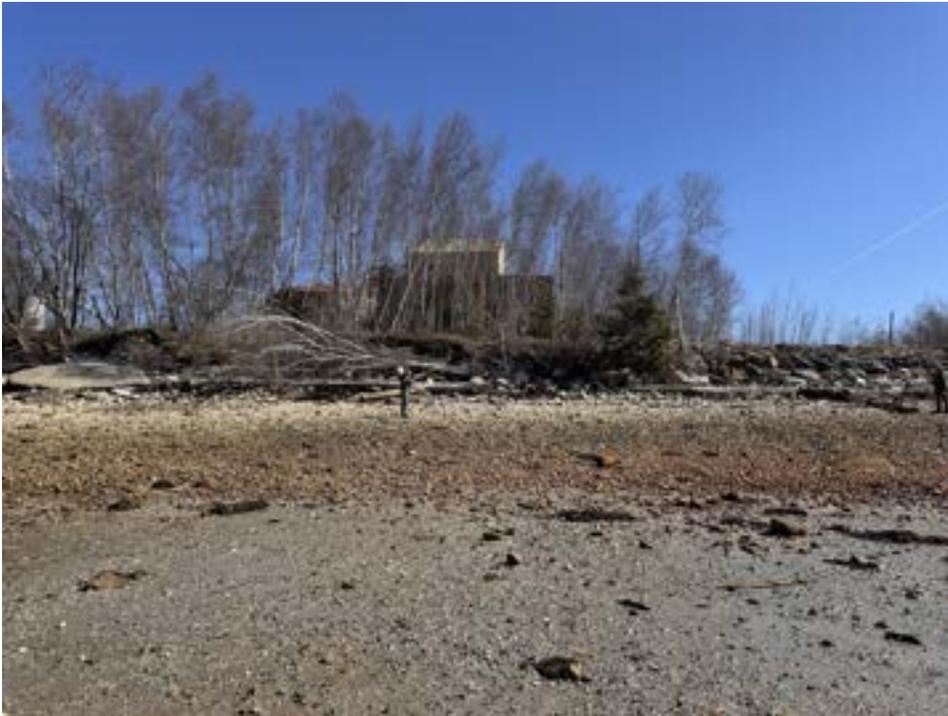
**SECTION 3- 100'**

Photo #5. Discolored intertidal sediment, concrete, failed riprap, newly installed riprap  
44.46468° N, 68.88003° W

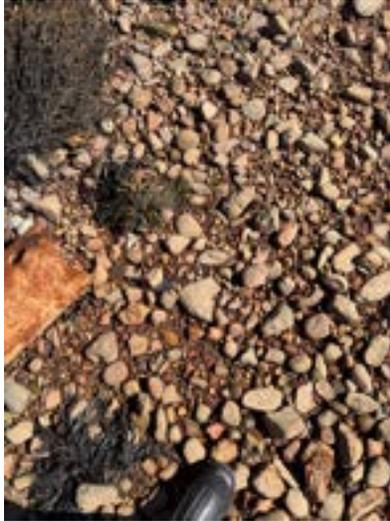
Photo #6 discolored sediment. Photo #7 exposed plastic riprap lining

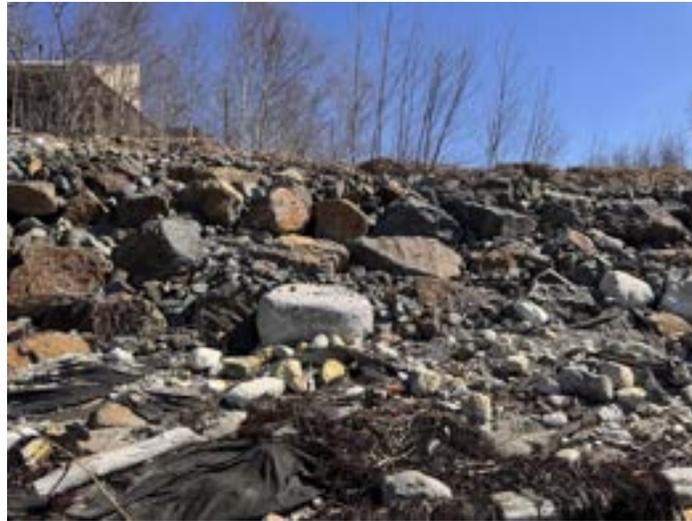
There are four sections of armored shoreline on the site. One is recent and appears stable; however, it shows significant plastic liner exposure, suggesting boulder movement and potential instability of the underlying soils. The three other areas of armored shoreline on site appear to be older, all of them have been overtopped by wave action and have indicators of downward movement and collapse (Photo #1, Attachment B). Two of the riprap structures are composed primarily of concrete pilings.

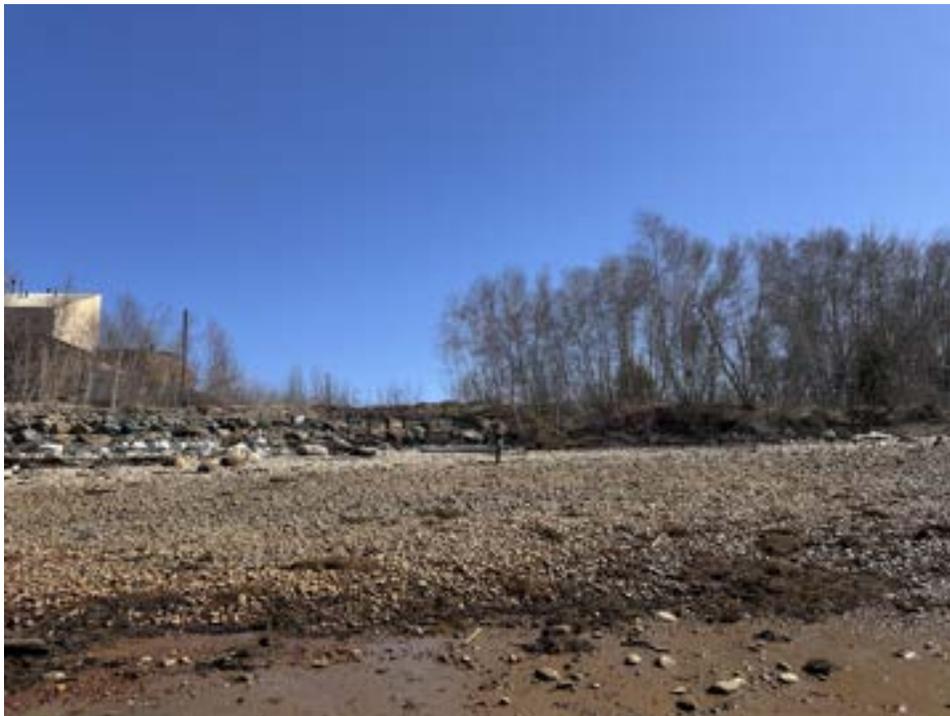
**SECTION 4- 100'**

Photo #8 newly installed riprap, exposed plastic, grey powdery sediment 44.46454° N, 68.87976° W

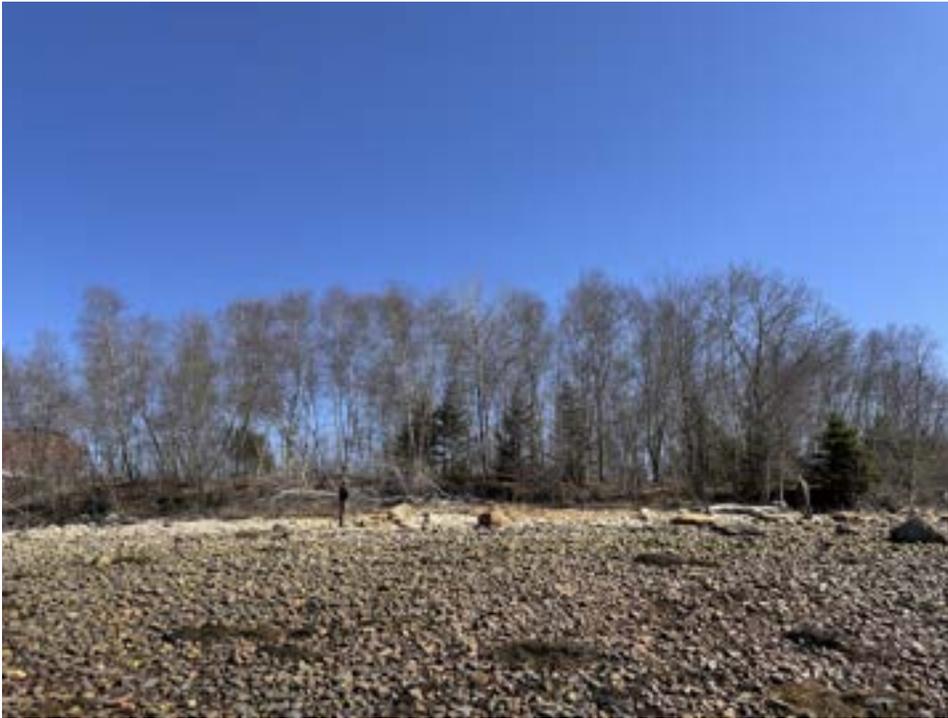
**SECTION 5- 100'**

Photo #9 vegetated unstable bluff, marsh, industrial debris on beach 44.46433° N, 68.87938° W

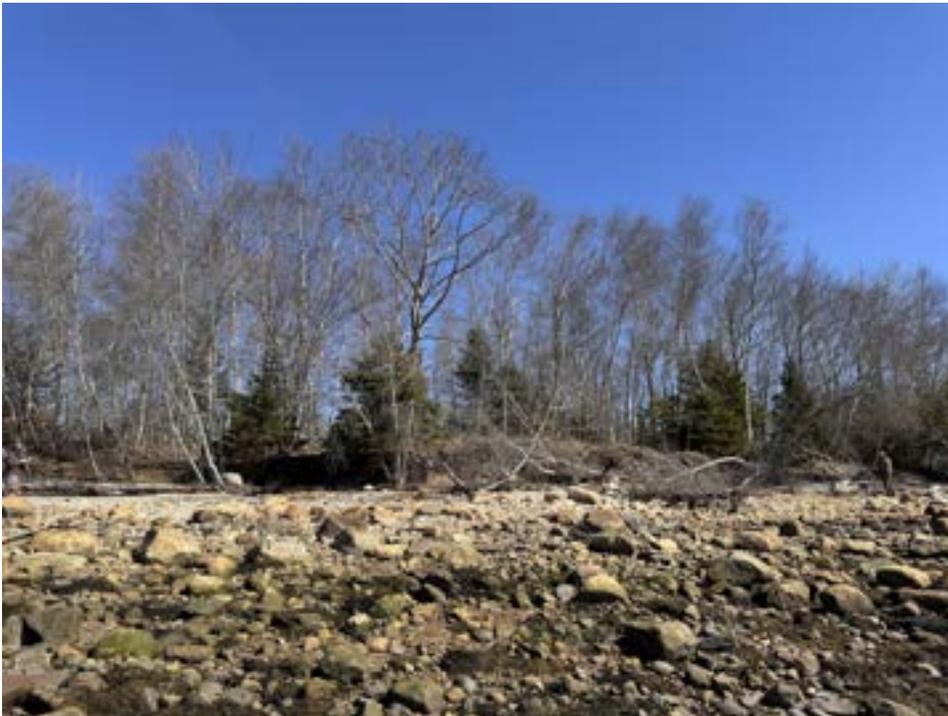
**SECTION 6- 100'**

Photo #10 vegetated unstable bluff, industrial debris on beach, grey powdery sediment pilings 44.46430° N, 68.87897° W

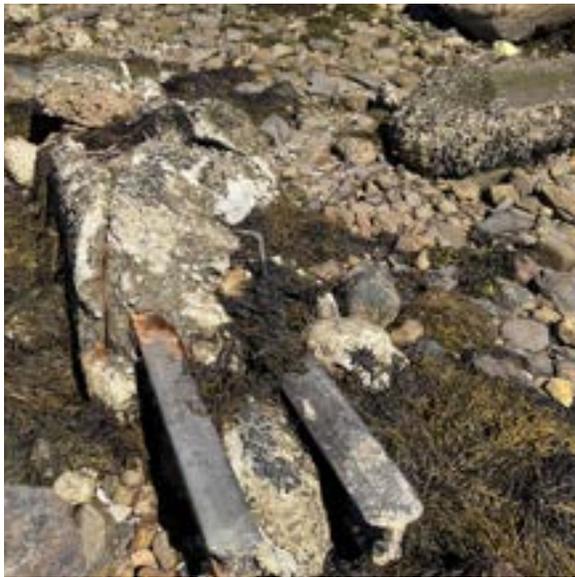
Photo #11 industrial debris

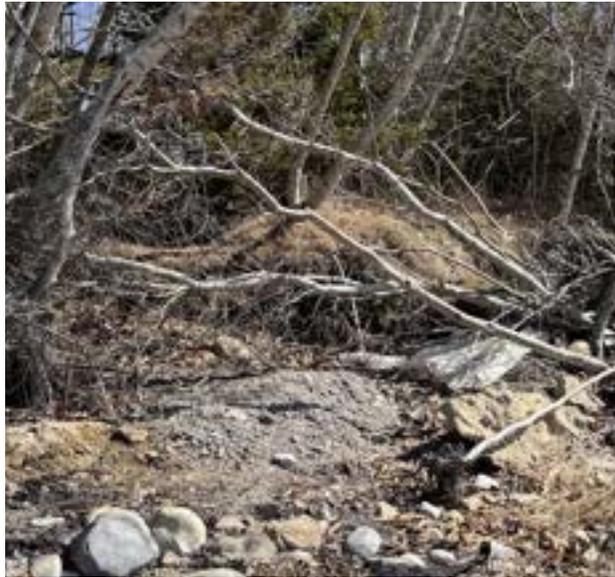
Photo #12 grey powdery sediment

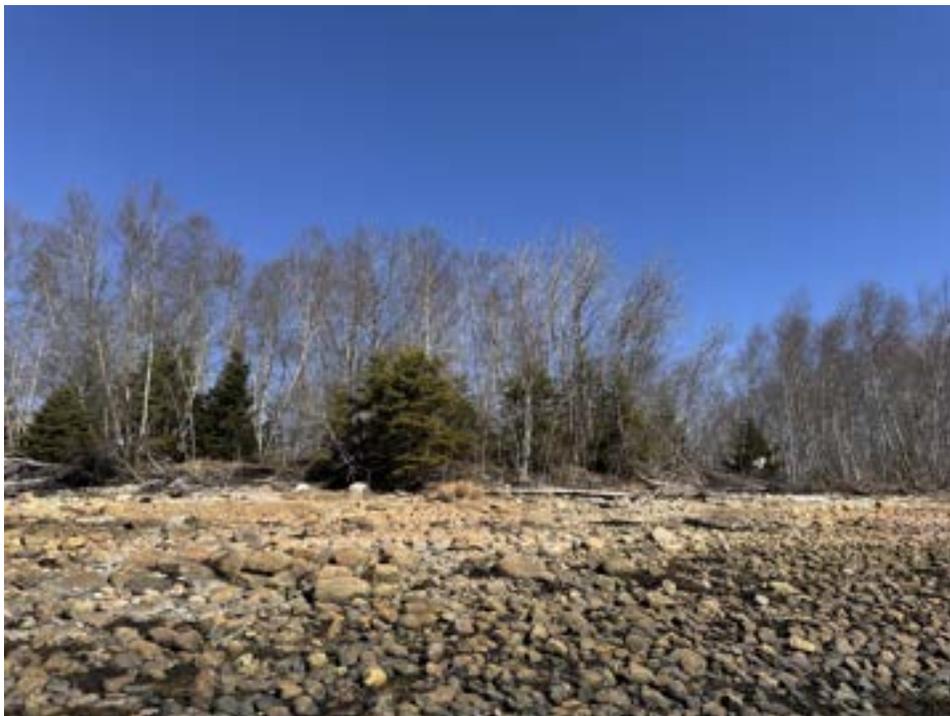
**SECTION 7: 100'**

Photo #13 vegetated unstable bluff, industrial debris on beach. 44.46430° N, 68.87852° W

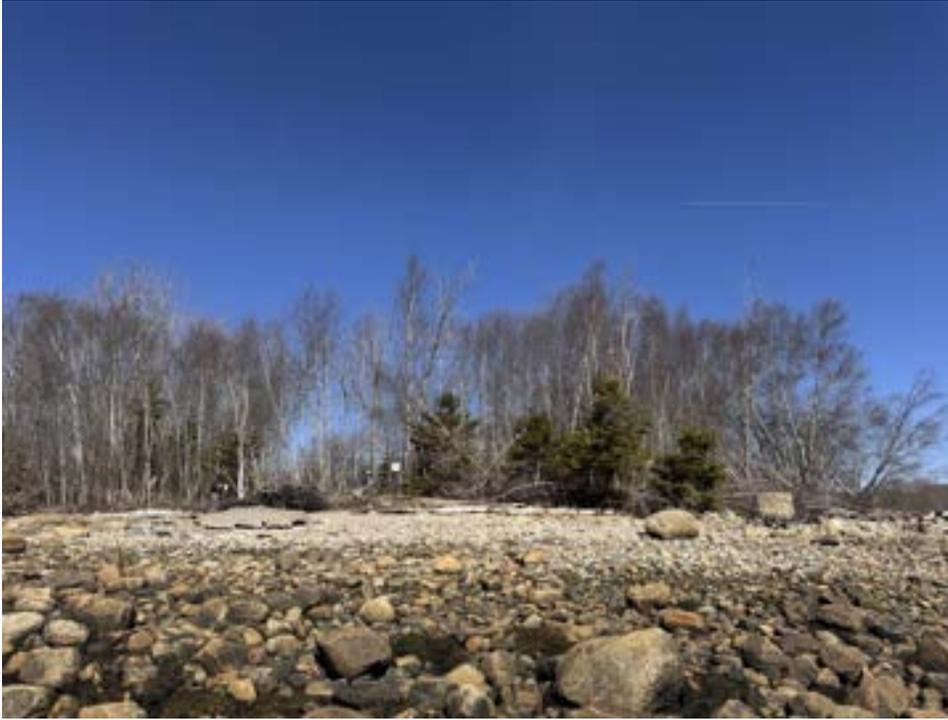
**SECTION 8- 100'**

Photo #14 vegetated unstable bluff, industrial debris on the beach. 44.46442° N, 68.87798° W

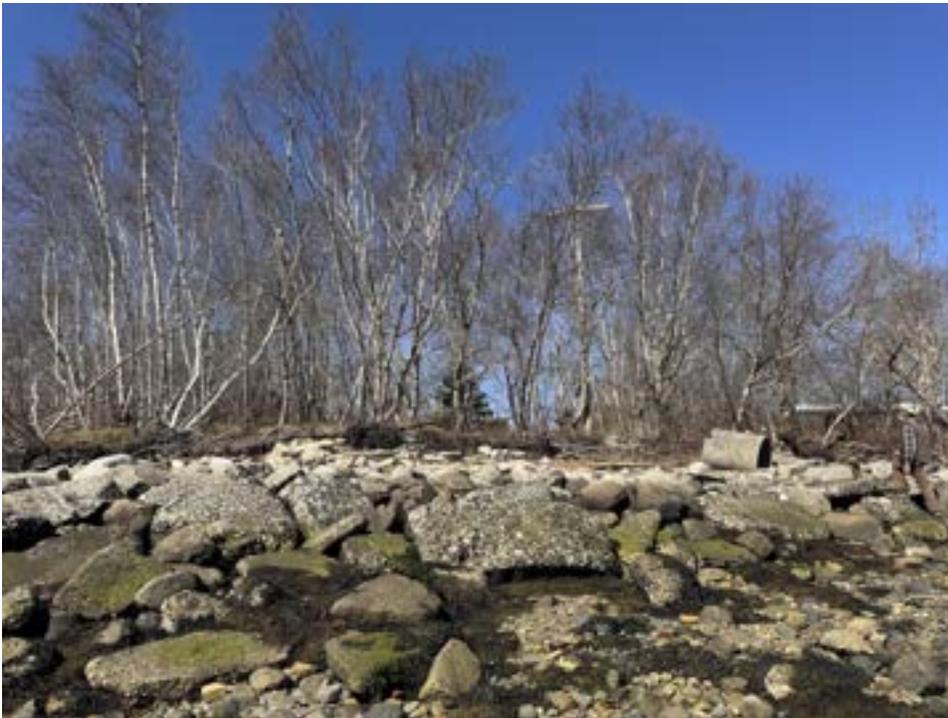
**SECTION 9- 100'**

Photo #15 concrete, industrial debris. 44.46485° N, 68.87779° W

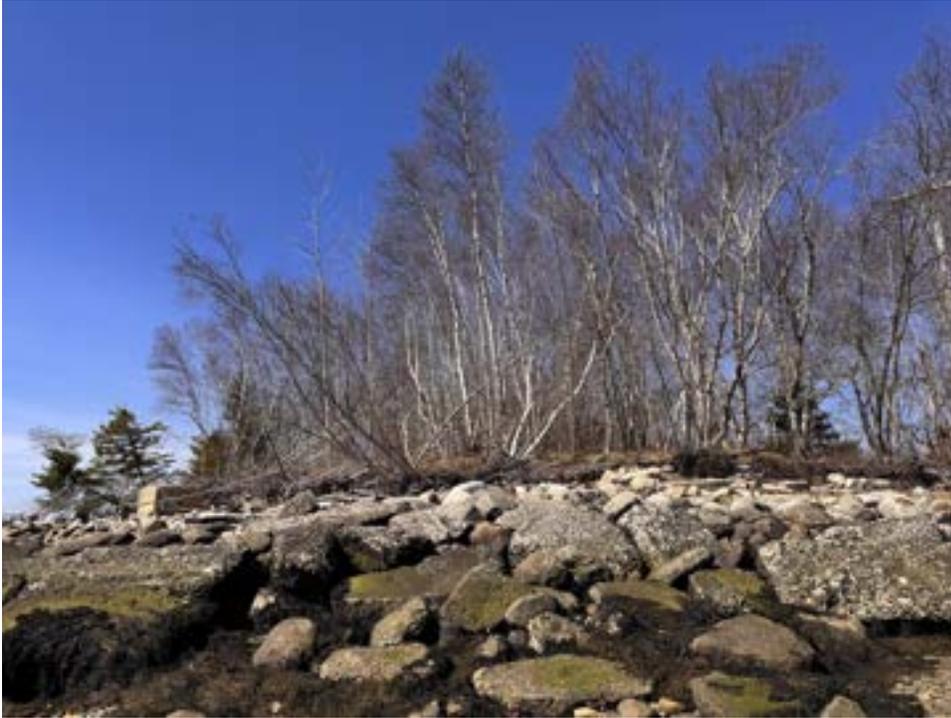
Photo #16 concrete, industrial debris

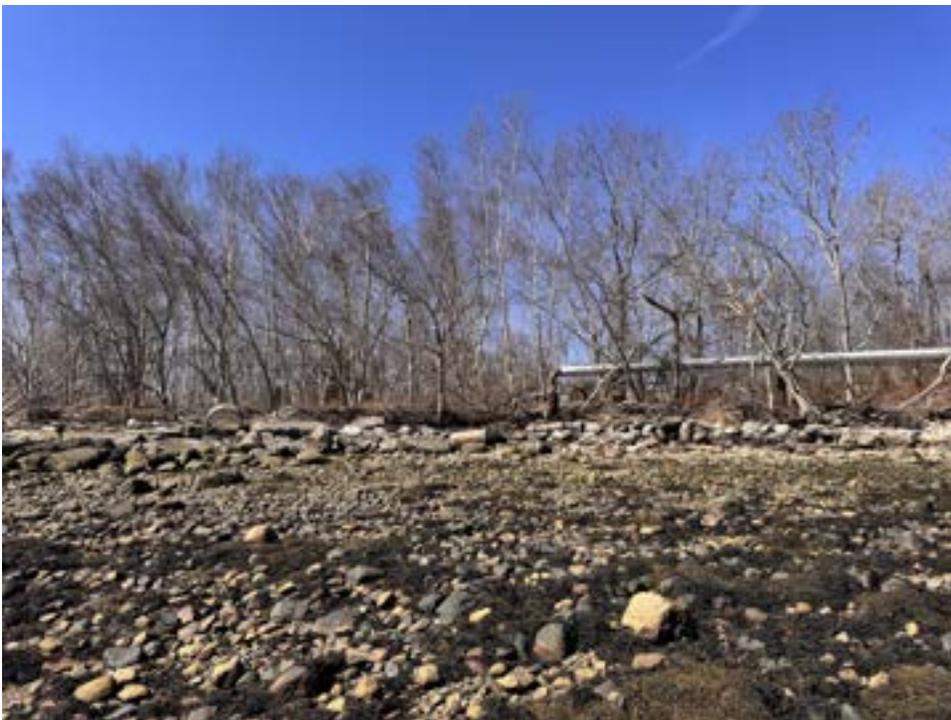
**SECTION 10- 100'**

Photo #17 concrete, industrial debris. 44.46506° N, 68.87778° W

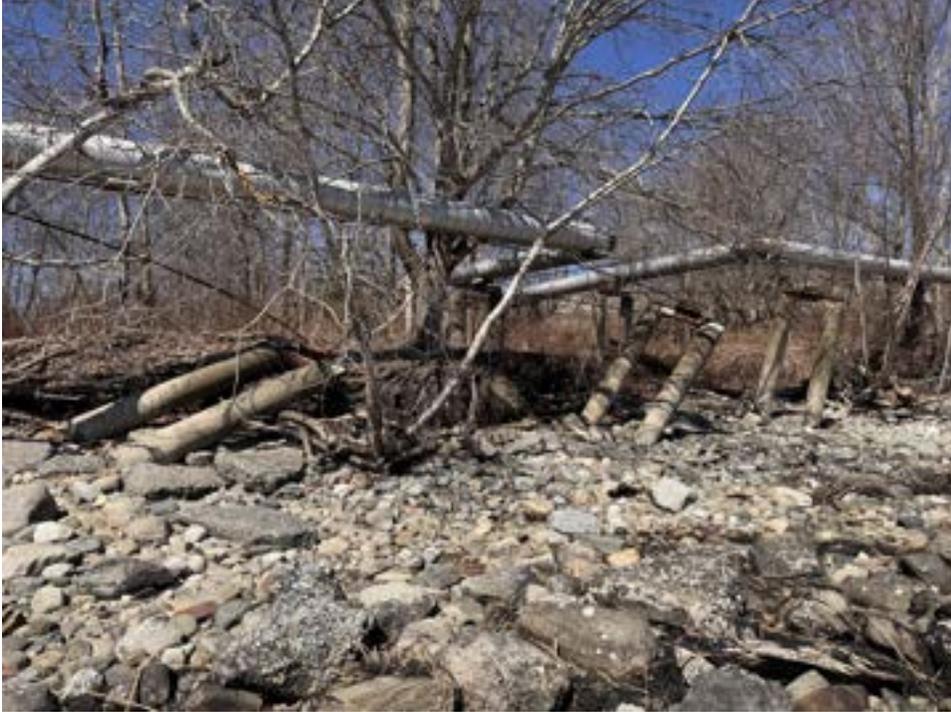
There is a failing pipeline structure that is no longer in use present to the north of Kidder Point that follows the bluff. Without removal, future storms and erosion will likely cause the pipeline and its structural components to fall into the Bay. The paint on the metal components contains lead and PCBs, and the wrap around the pipe itself contains asbestos. All of these materials should be properly removed and disposed of.

Photo #18 inactive & collapsing industrial pipe

We strongly recommend the complete removal of loose industrial debris from the intertidal zone, including abandoned pipelines and collapsing structural supports. Where deemed safe and feasible, we also support the removal of contaminated soils, derelict buildings, and construction debris from the adjacent shoreland zone (defined as 75 feet inland from the highest annual tide line). The scope of our assessment was not comprehensive enough to determine the extent to which removal of materials within the bluff is safe and feasible. Whatever cannot be physically removed from the site needs to be capped in place to prevent further erosion and release of materials.

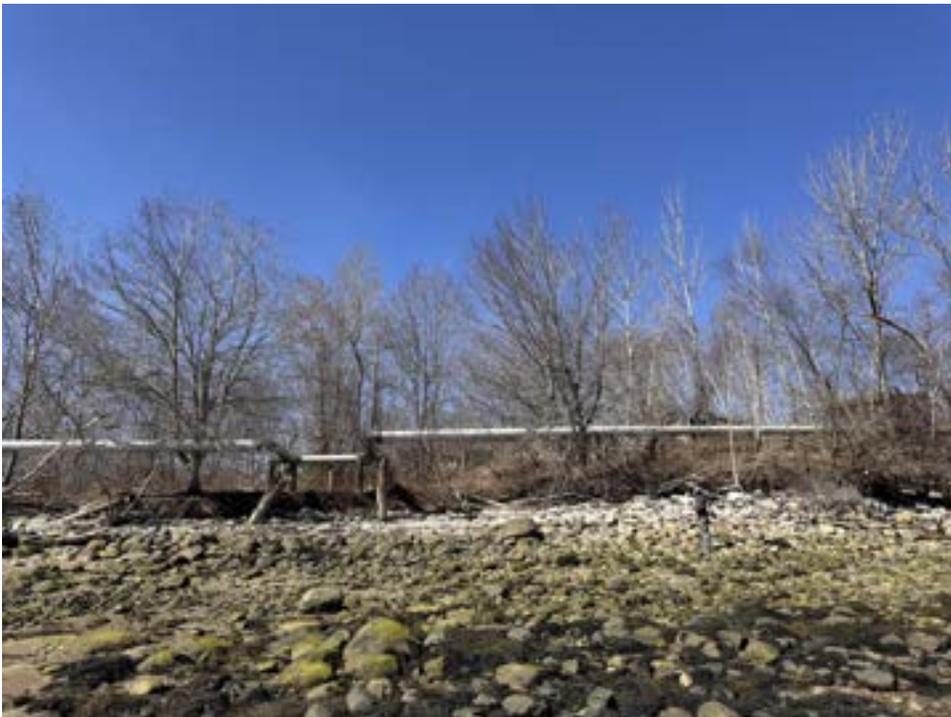
**SECTION 11- 100'**

Photo #19 unstable bluff, inactive industrial pipe, unstable riprap 44.46528° N, 68.87786° W
