## **SUMMARY OF SEARSPORT SEDIMENT TESTING.**

By Dr. Mark Green,

St Josephs College April 9, 2014

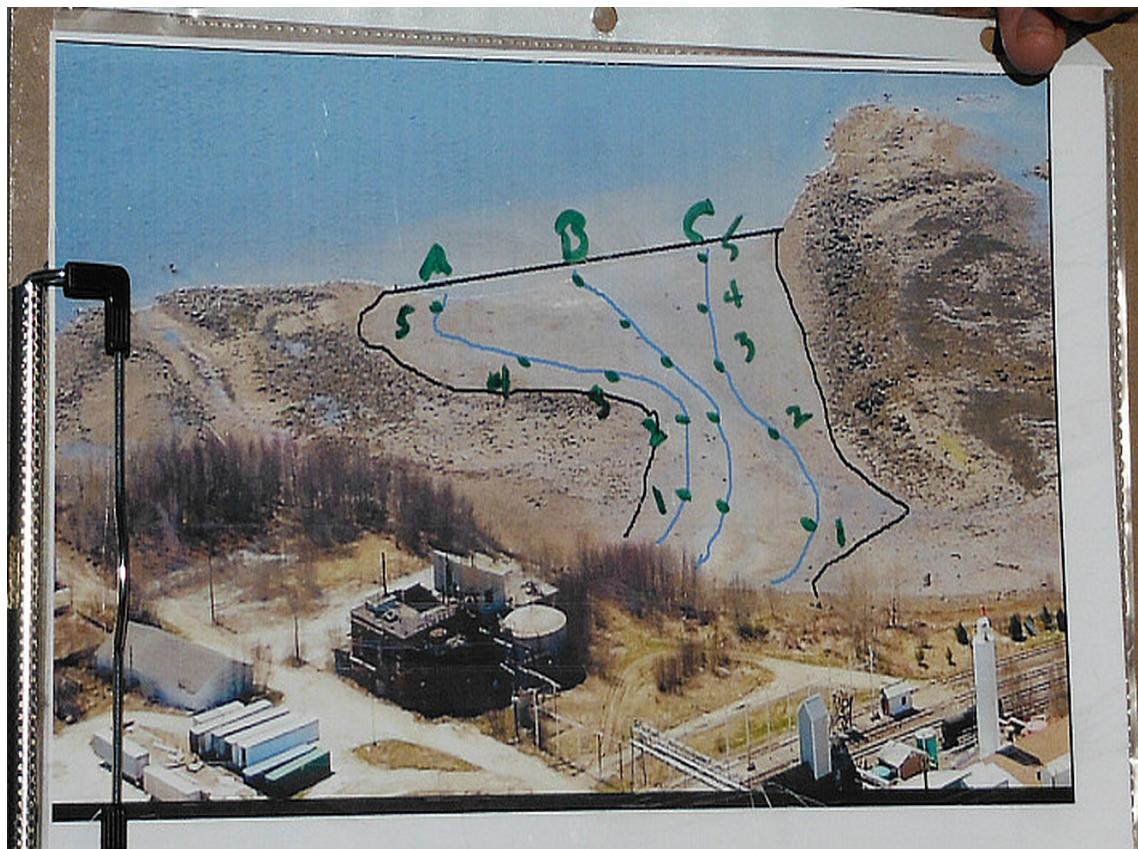
Sediment testing 050114. Sample lines E in lower photo)

Geographic Features and Suspected Pollution & Waste Sites, GAC Chemical, Kidder Point, Stockton Harbor. May 1, 2013

A = Acid Tank, abnd'd.  
 B = Eroding tailings and fill  
 C = Sulfuric Acid plant, abnd'd  
 D = Add'l eroding tailings  
 E= Tainted Runoff 1  
 F= Tainted Runoff 2  
 G= low pH intertidal mud  
 H= Ledge betw Runoff 1 and 2.  
 I= Ledge betw Runoff 2 and cove  
 S= Sandbar (Clamflat remediation)  
 K = Operating GAC facilities  
 \* = sediment test area E  
 Project Lighthawk photo

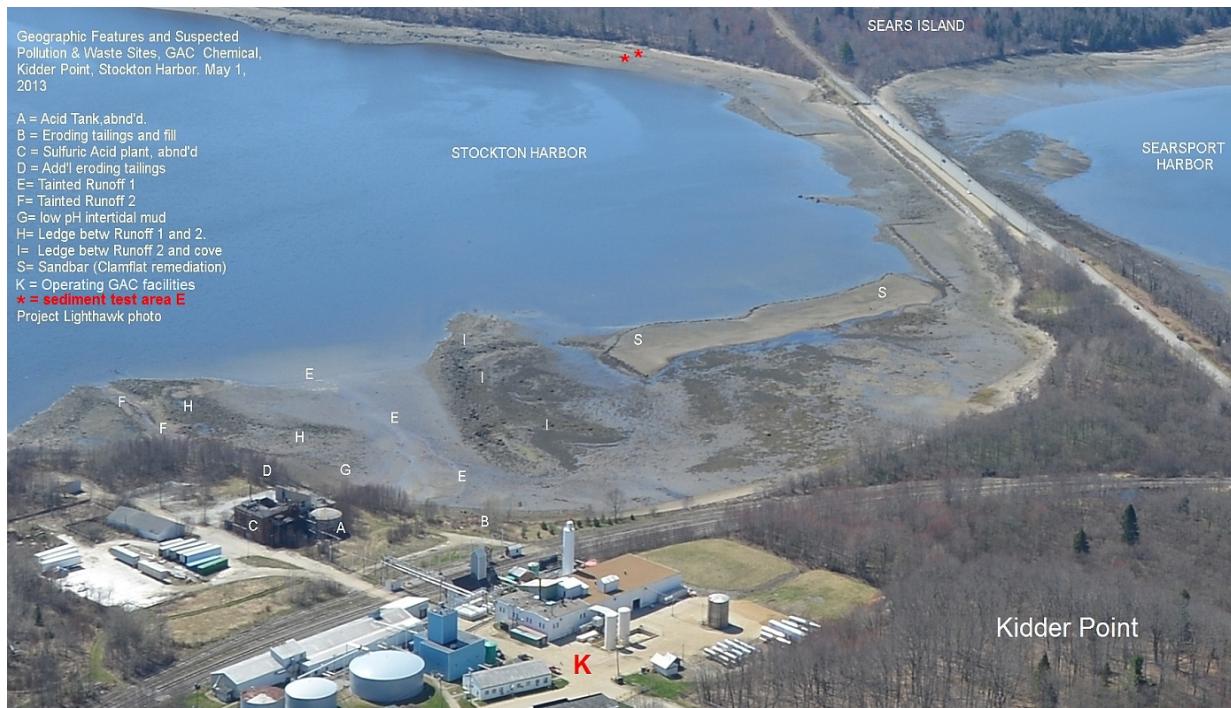
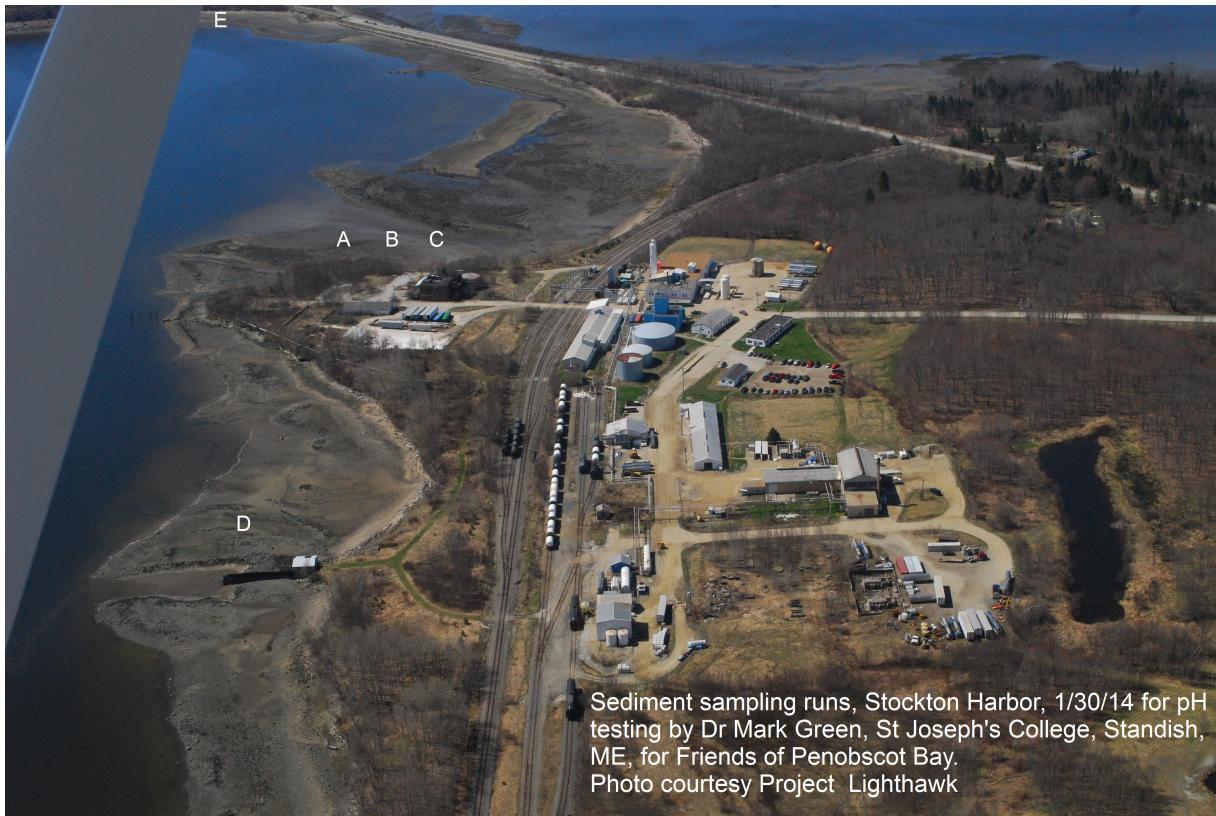
Sediment sampling runs, Stockton Harbor, 1/30/14 for pH testing by Dr Mark Green, St Joseph's College, Standish, ME, for Friends of Penobscot Bay.  
Photo courtesy Project Lighthawk
