**GAC CHEMICAL CORPORATION
PERMIT BY RULE NOTIFICATION**

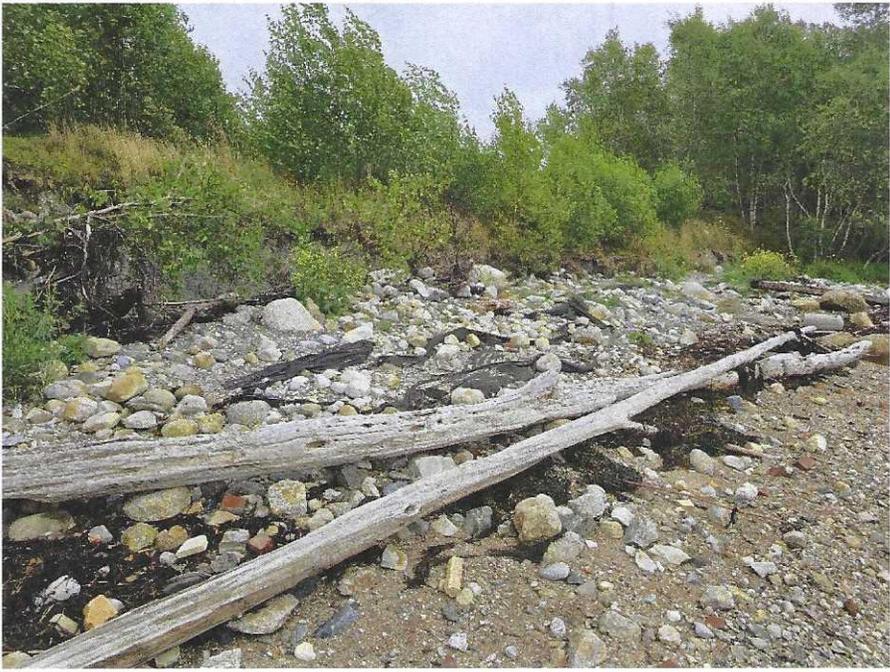
Photo No. 1

Photo Date: July 30, 2024	
Site Location: Stockton Harbor	
Description: Dislodged riprap and exposed geotextile fabric at toe of slope	
Photo By: Eric Madachik

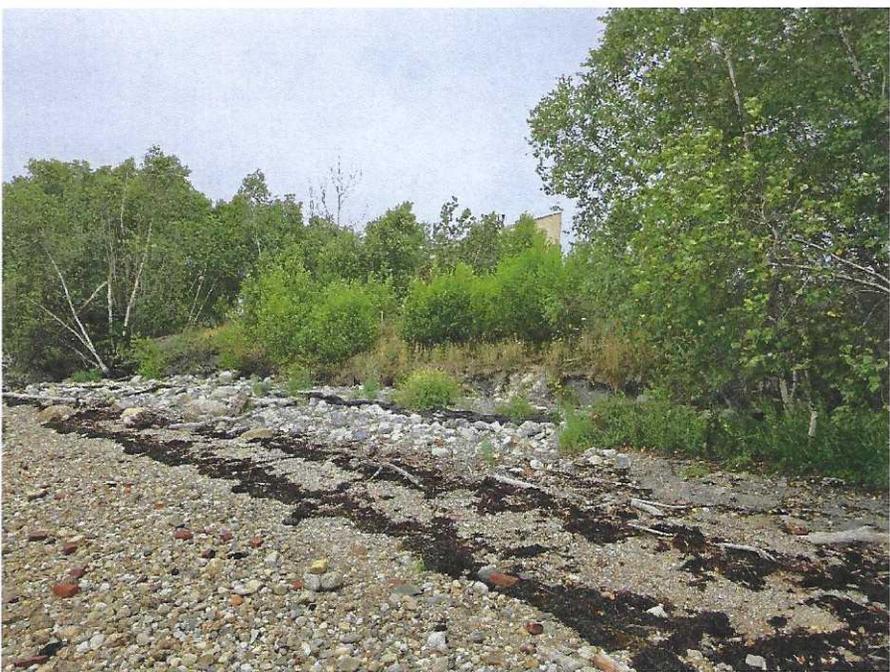
Photo No. 2

Photo Date: July 30, 2024	
Site Location: Stockton Harbor	
Description: Wide view of stabilization area	
Photo By: Eric Madachik

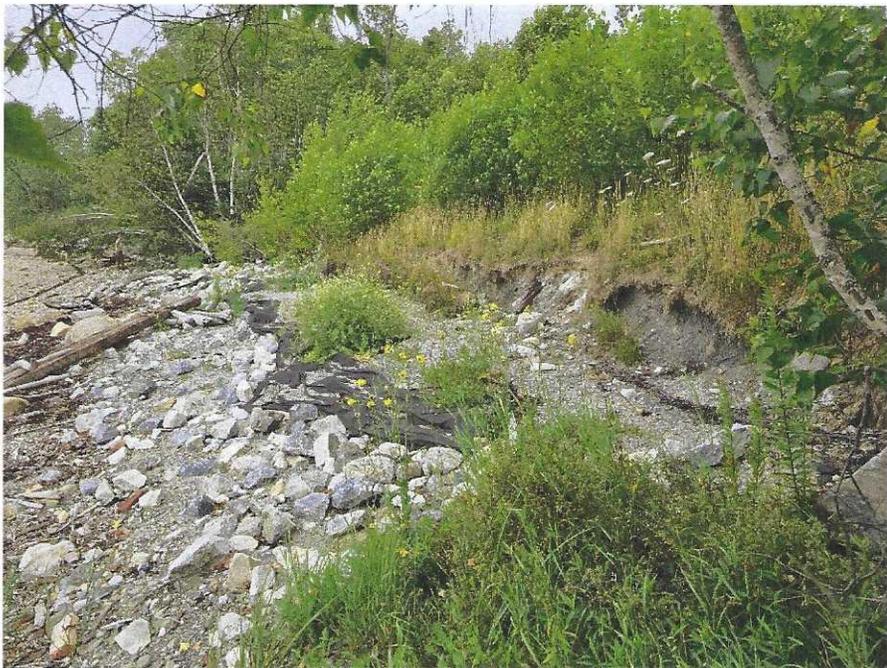
Photo No. 3

Photo Date: July 30, 2024	
Site Location: Stockton Harbor	
Description: Erosion and undercutting of soil	
Photo By: Eric Madachik

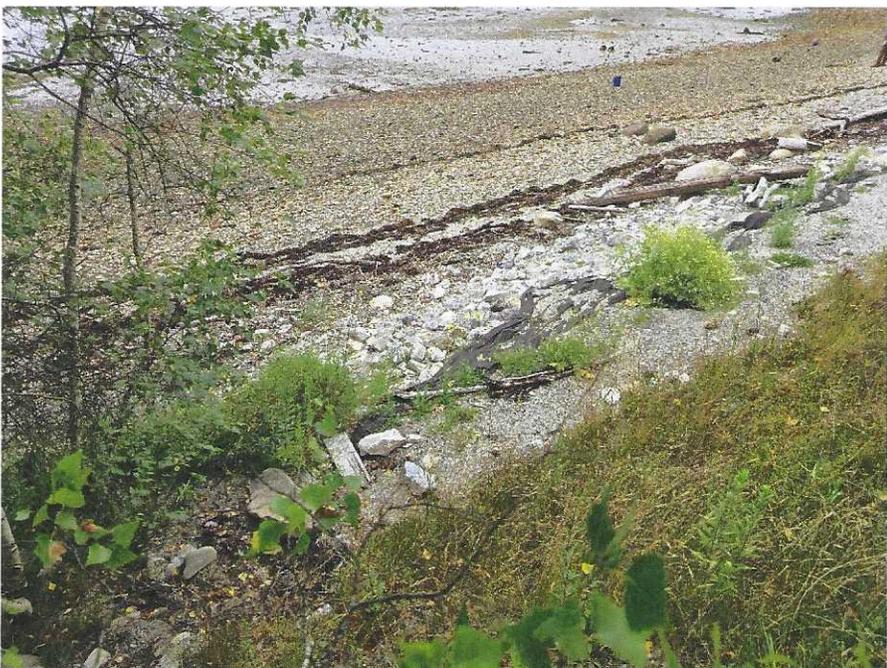
Photo No. 4

Photo Date: July 30, 2024	
Site Location: Stockton Harbor	
Description: Erosion, dislodged riprap, and geotextile viewed from top of slope	
Photo By: Eric Madachik
