**INVESTIGATIONS SUMMARY REPORT  
VOLUNTARY RESPONSE ACTION PROGRAM  
34 KIDDER POINT ROAD  
SEARSPORT, MAINE**

**NOVEMBER 2014  
JN: 10060.007**

## INVESTIGATIONS SUMMARY REPORT VOLUNTARY RESPONSE ACTION PROGRAM GAC CHEMICAL

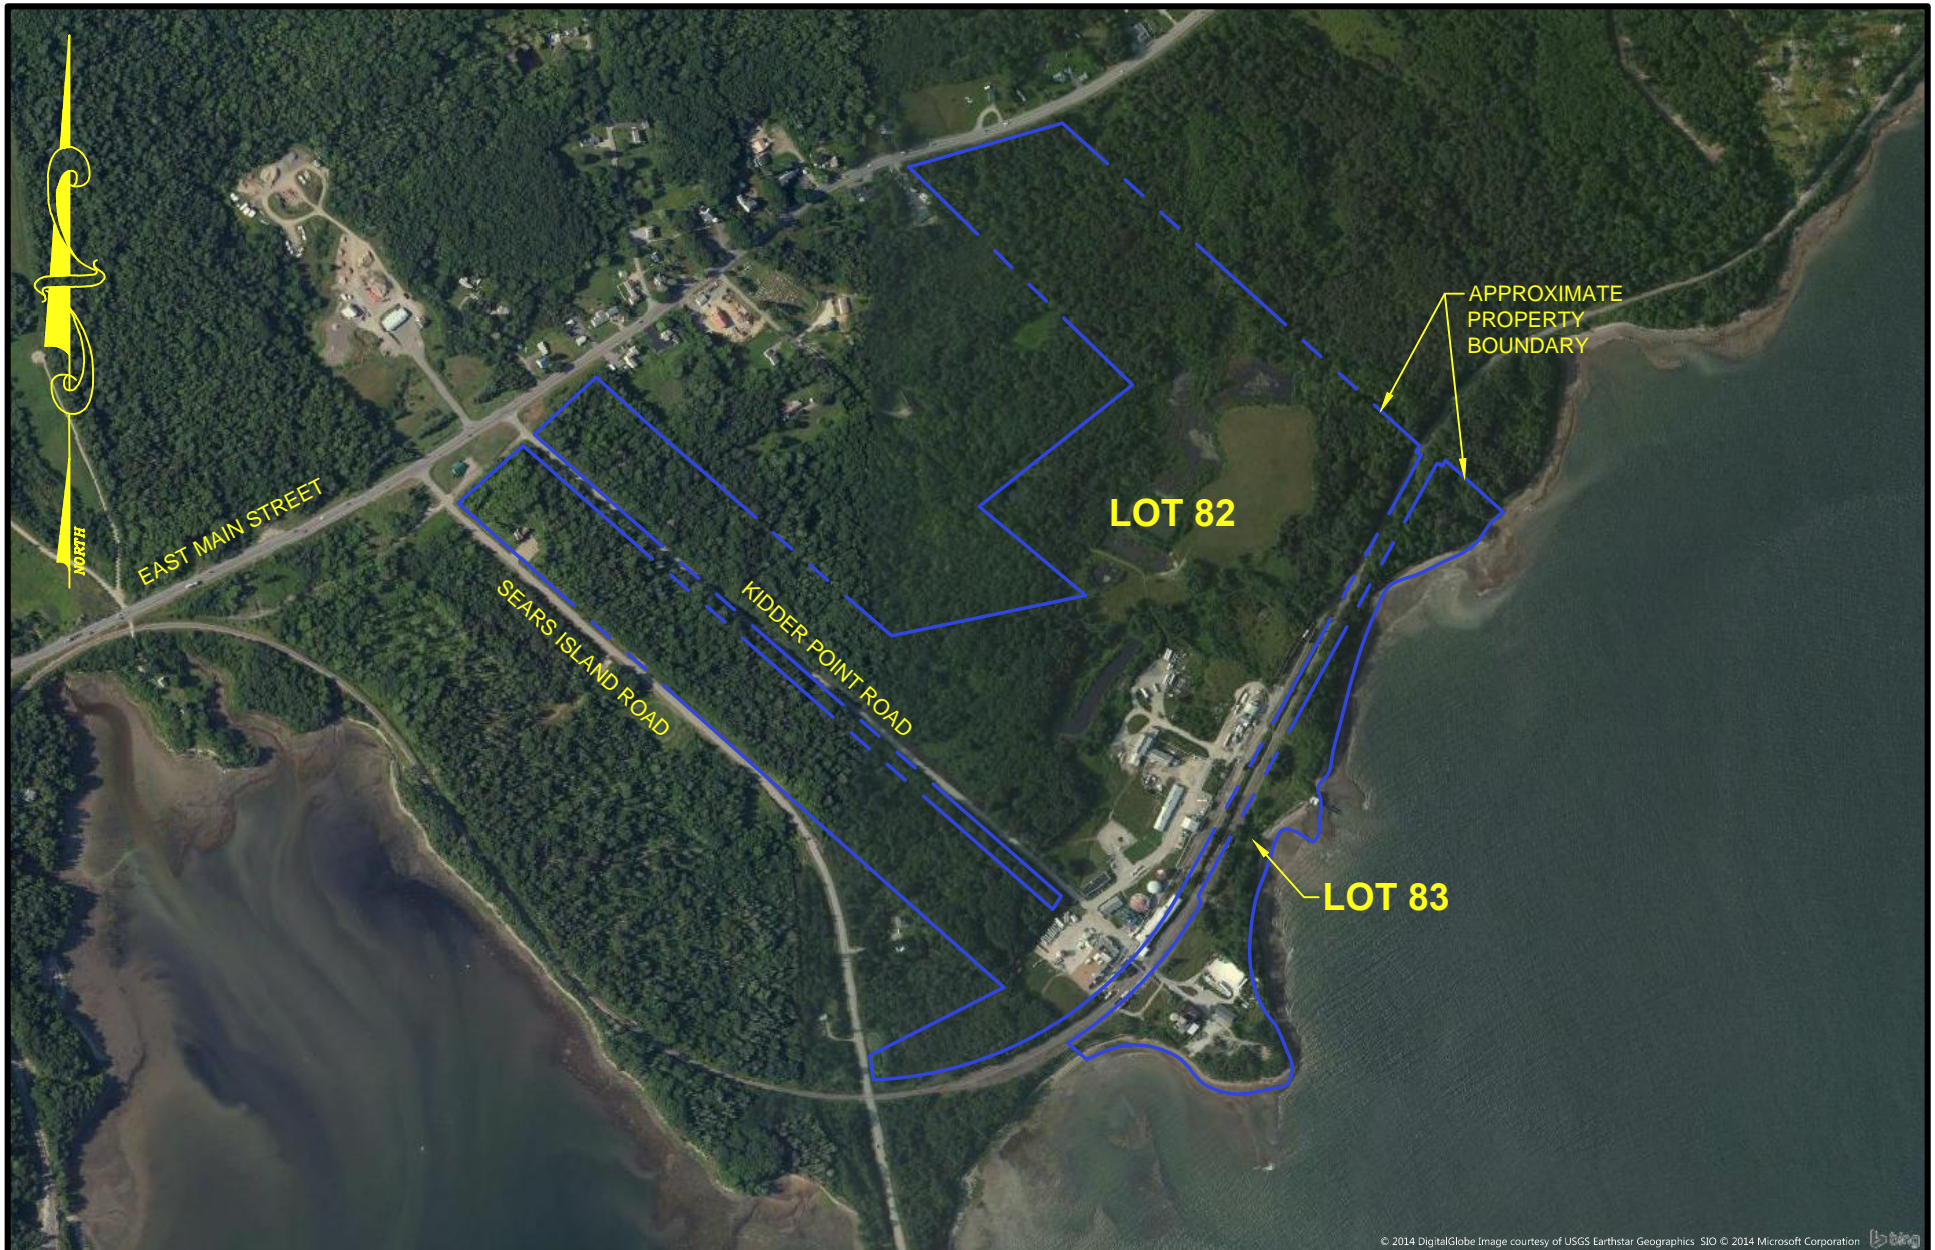
**FIGURE 2**  
**SITE PLAN**

Groundwater within each soil boring (if encountered) was sampled for pH using an in-situ (down-hole) pH meter. The down-hole pH meter was calibrated after each use. The results of the groundwater pH samples are shown on **Table 3** and depicted on **Figure 2**.

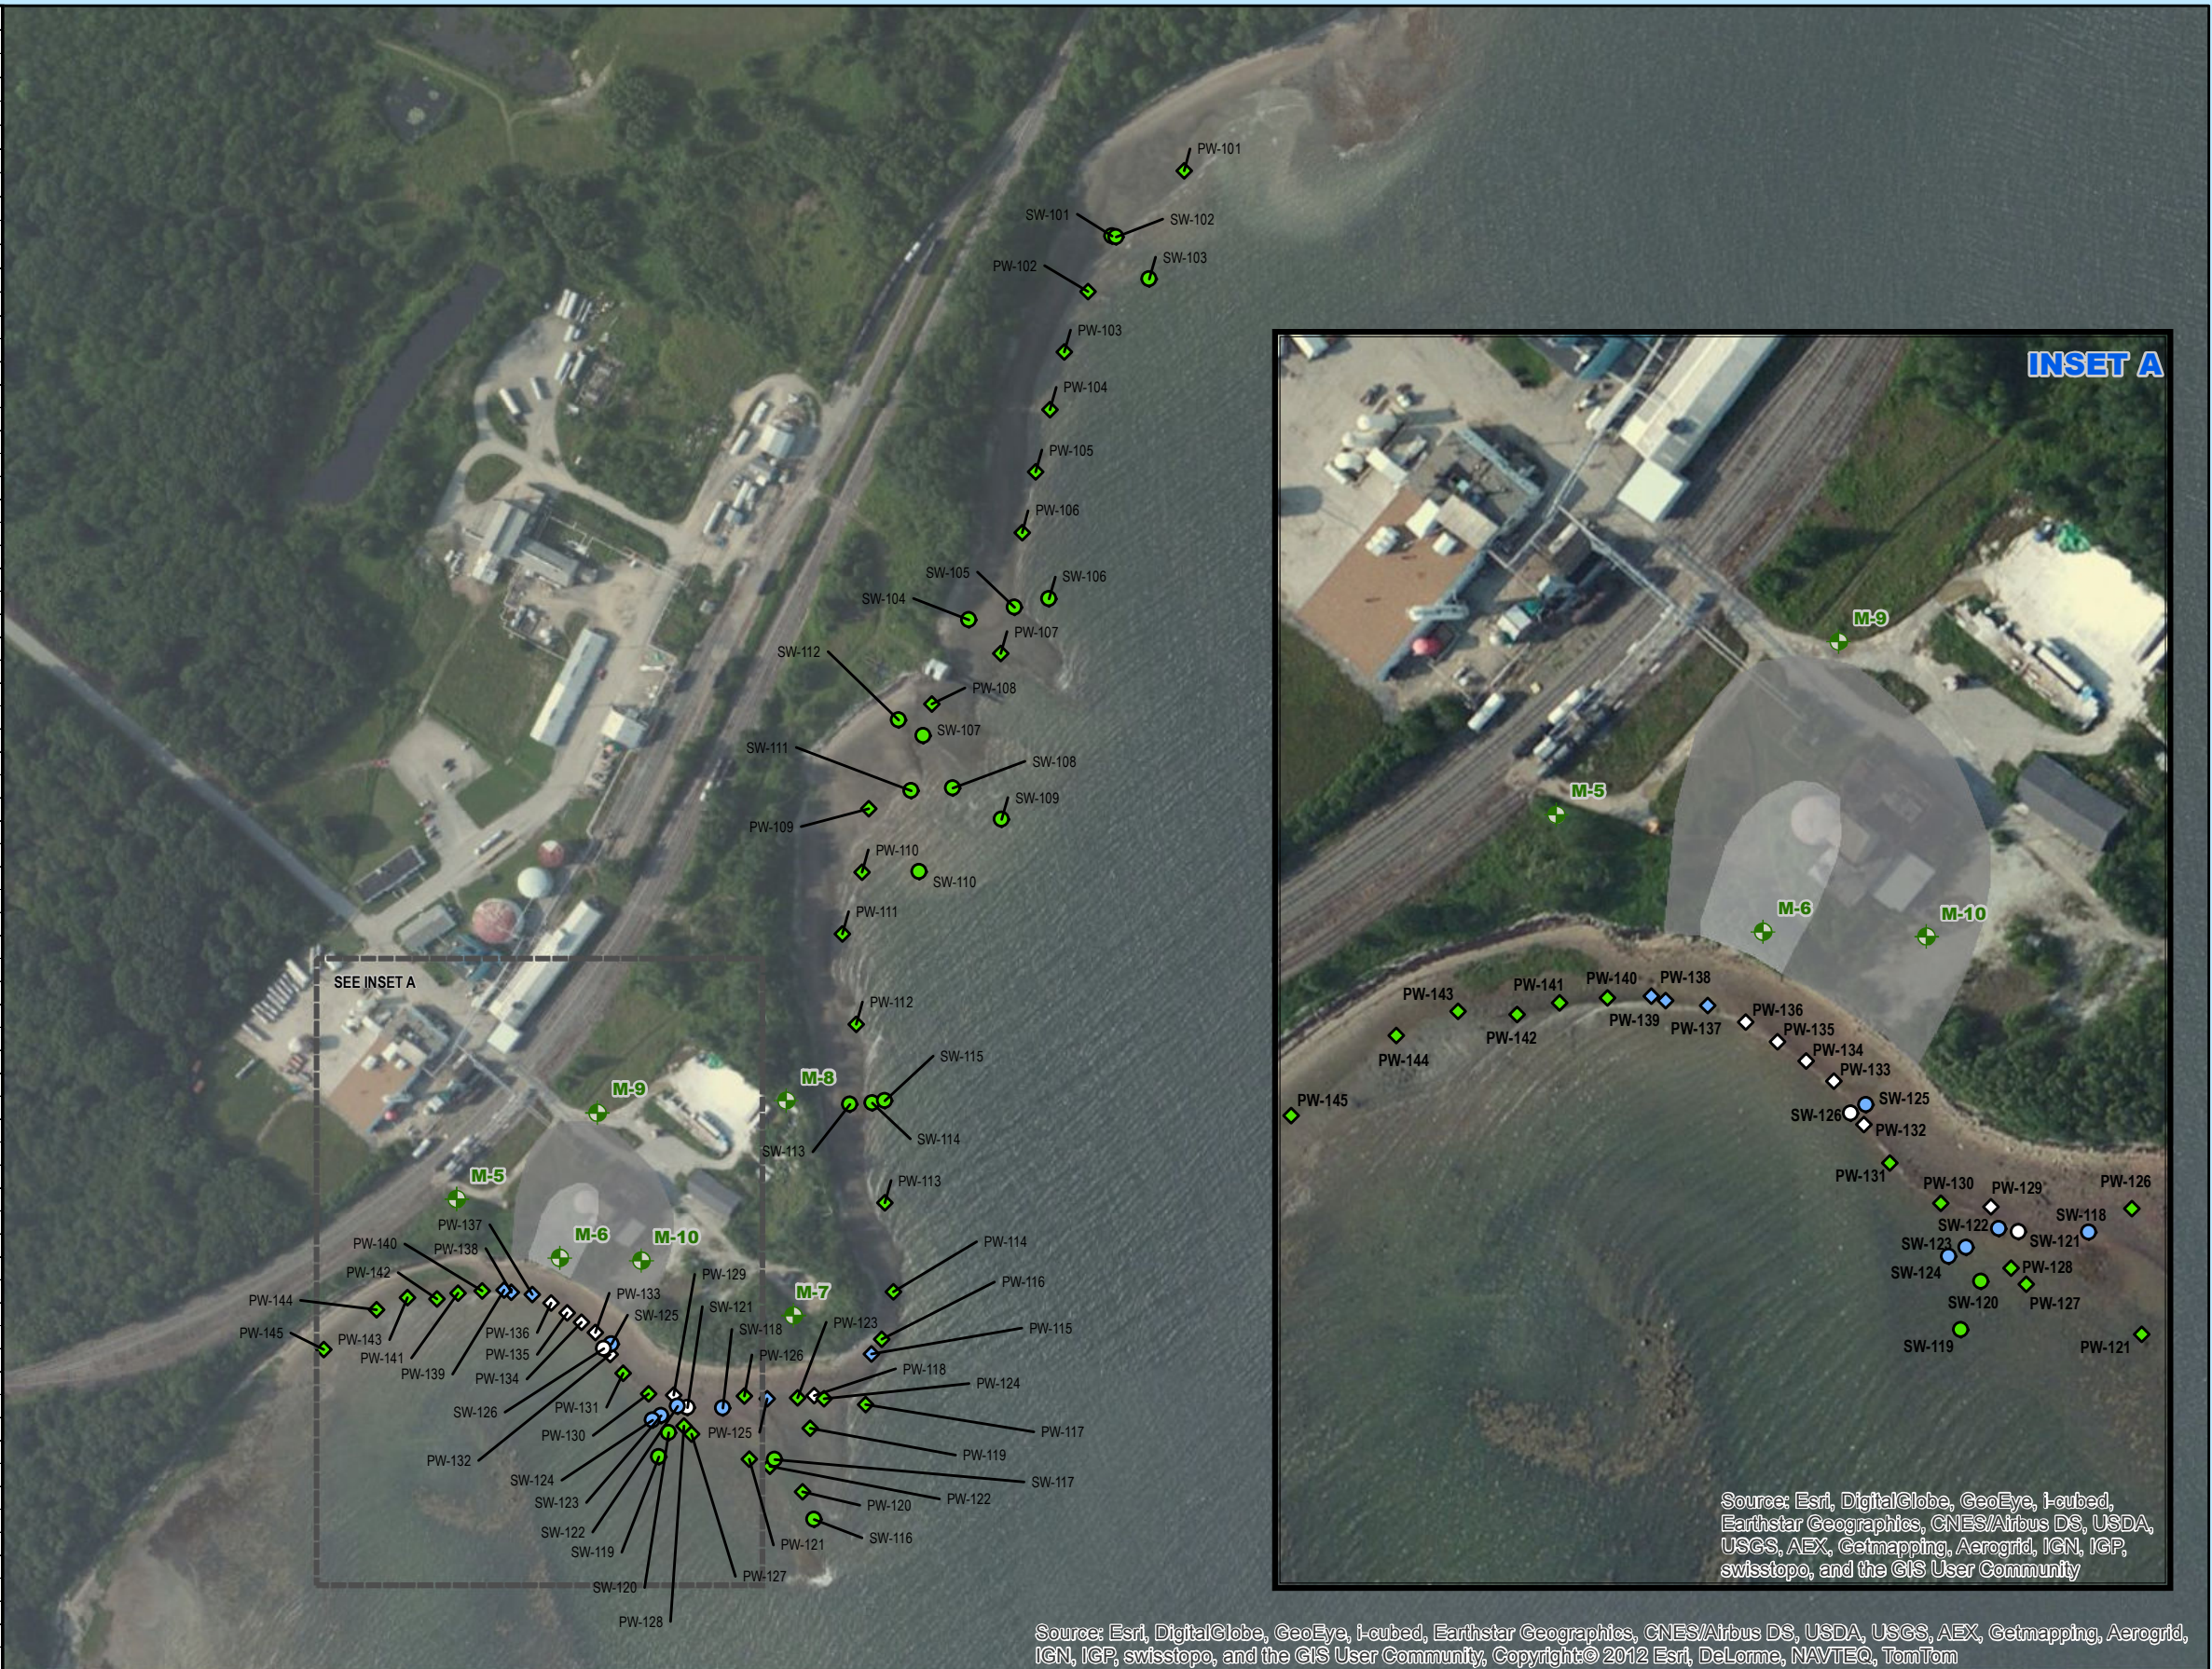
**FIGURE 3**  
**INTERTIDAL SAMPLING LOCATION PLAN**

Location	pH (stu)
PW-101	7.6
PW-102	7.5
PW-103	7.4
PW-104	7.3
PW-105	7.5
PW-106	7.5
PW-107	7.5
PW-108	7.4
PW-109	7.5
PW-110	7.6
PW-111	7.6
PW-112	7.6
PW-113	7.4
PW-114	7.4
PW-115	5.2
PW-116	7.0
PW-117	7.0
PW-118	3.1
PW-119	7.1
PW-120	7.5
PW-121	6.7
PW-122	6.7
PW-123	6.8
PW-124	6.1
PW-125	4.6
PW-126	6.9
PW-127	7.1
PW-128	6.9
PW-129	3.0
PW-130	6.4
PW-131	6.9
PW-132	2.6
PW-133	2.4
PW-134	2.6
PW-135	2.2
PW-136	2.6
PW-137	4.6
PW-138	5.1
PW-139	5.6
PW-140	6.1
PW-141	6.6
PW-142	6.3
PW-143	6.7
PW-144	6.7
PW-145	6.8
SW-101	7.0
SW-102	7.5
SW-103	7.7
SW-104	7.1
SW-105	7.8
SW-106	7.7
SW-107	7.6
SW-108	7.4
SW-109	7.6
SW-110	7.6
SW-111	7.5
SW-112	7.4
SW-113	6.9
SW-114	7.3
SW-115	7.5
SW-116	7.2
SW-117	6.3
SW-118	5.6
SW-119	7.3
SW-120	7.3
SW-121	4.0
SW-122	4.2
SW-123	5.5
SW-124	5.9
SW-125	5.2
SW-126	2.3

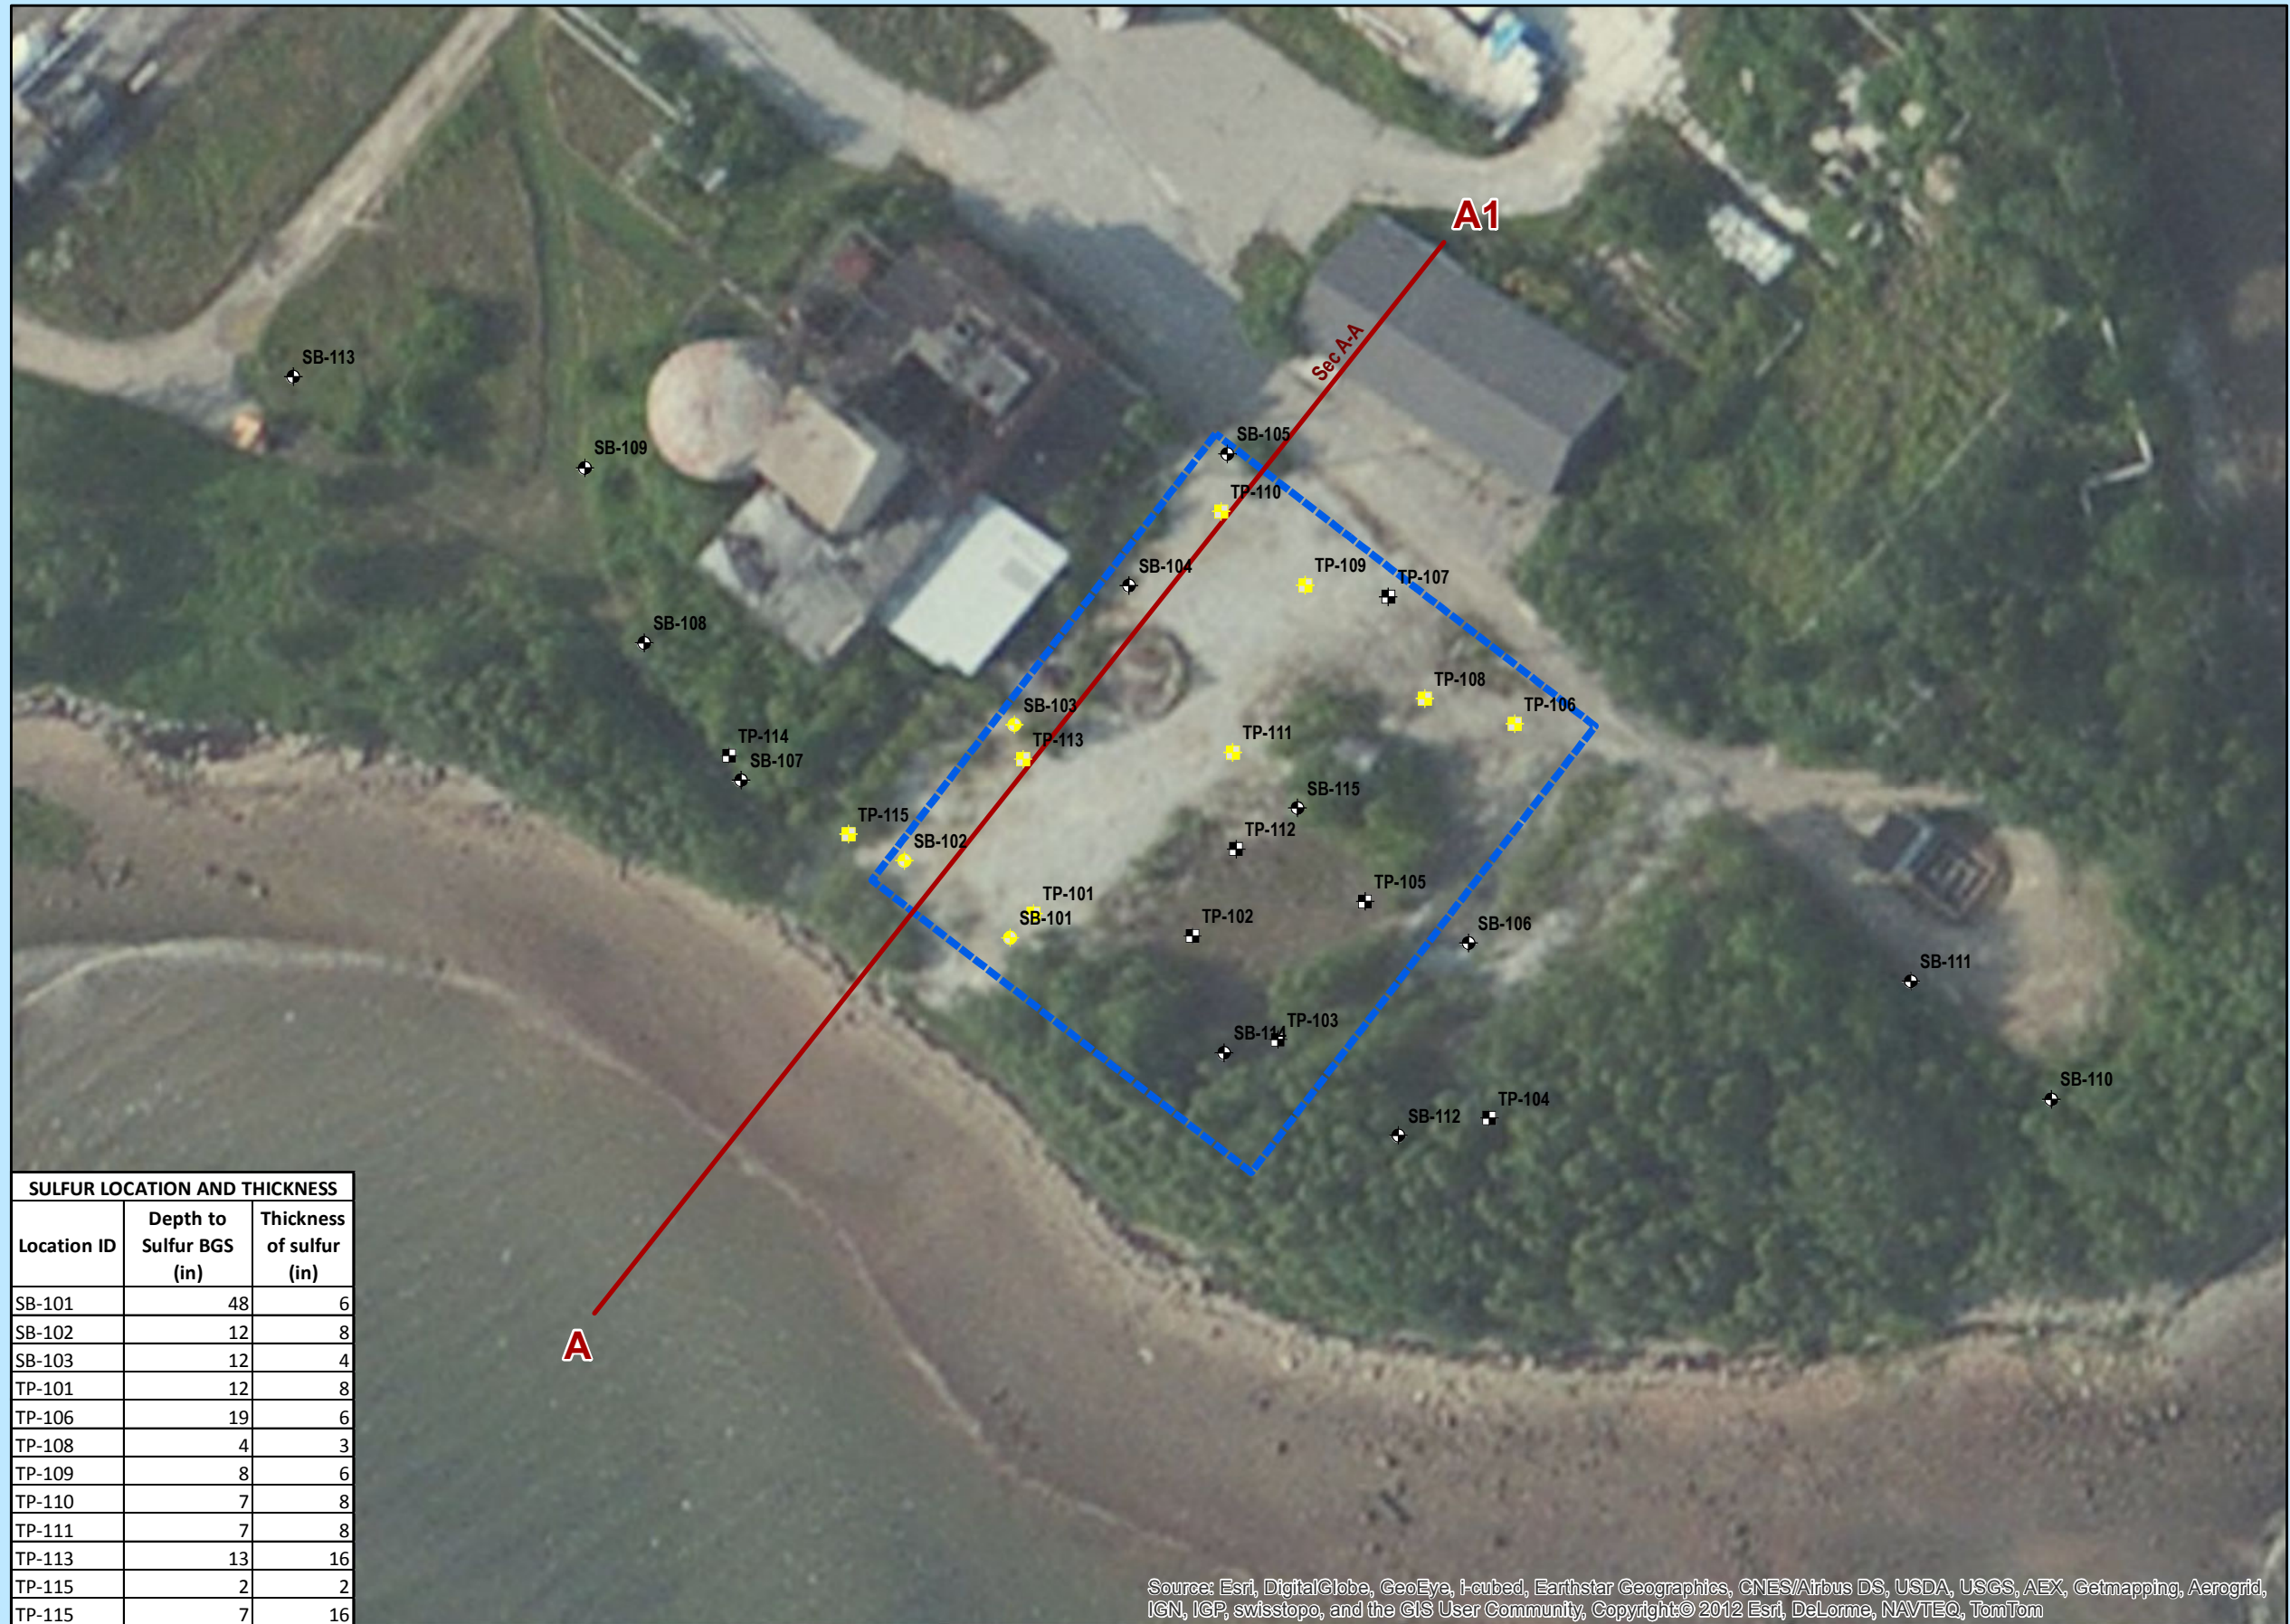
**FIGURE 5**  
**TEST PIT LOCATION PLAN**

SULFUR LOCATION AND THICKNESS		
Location ID	Depth to Sulfur BGS (in)	Thickness of sulfur (in)
SB-101	48	6
SB-102	12	8
SB-103	12	4
TP-101	12	8
TP-106	19	6
TP-108	4	3
TP-109	8	6
TP-110	7	8
TP-111	7	8
TP-113	13	16
TP-115	2	2
TP-115	7	16

Test pitting at the Site was conducted on October 10, 2014. Test pits were excavated by Kinney’s Construction up to depths of seven feet BGS in some areas. Excavation of the test pits was overseen by CES and MDEP. Fifteen test pits were excavated and the soil encountered in each test pit was documented with photos and test pit logs. Copies of the test pit logs with photos are included in **Appendix E**. **Figure 5** and **Table 7** depict the sulfur observed within each test pit and soil boring at the Site.

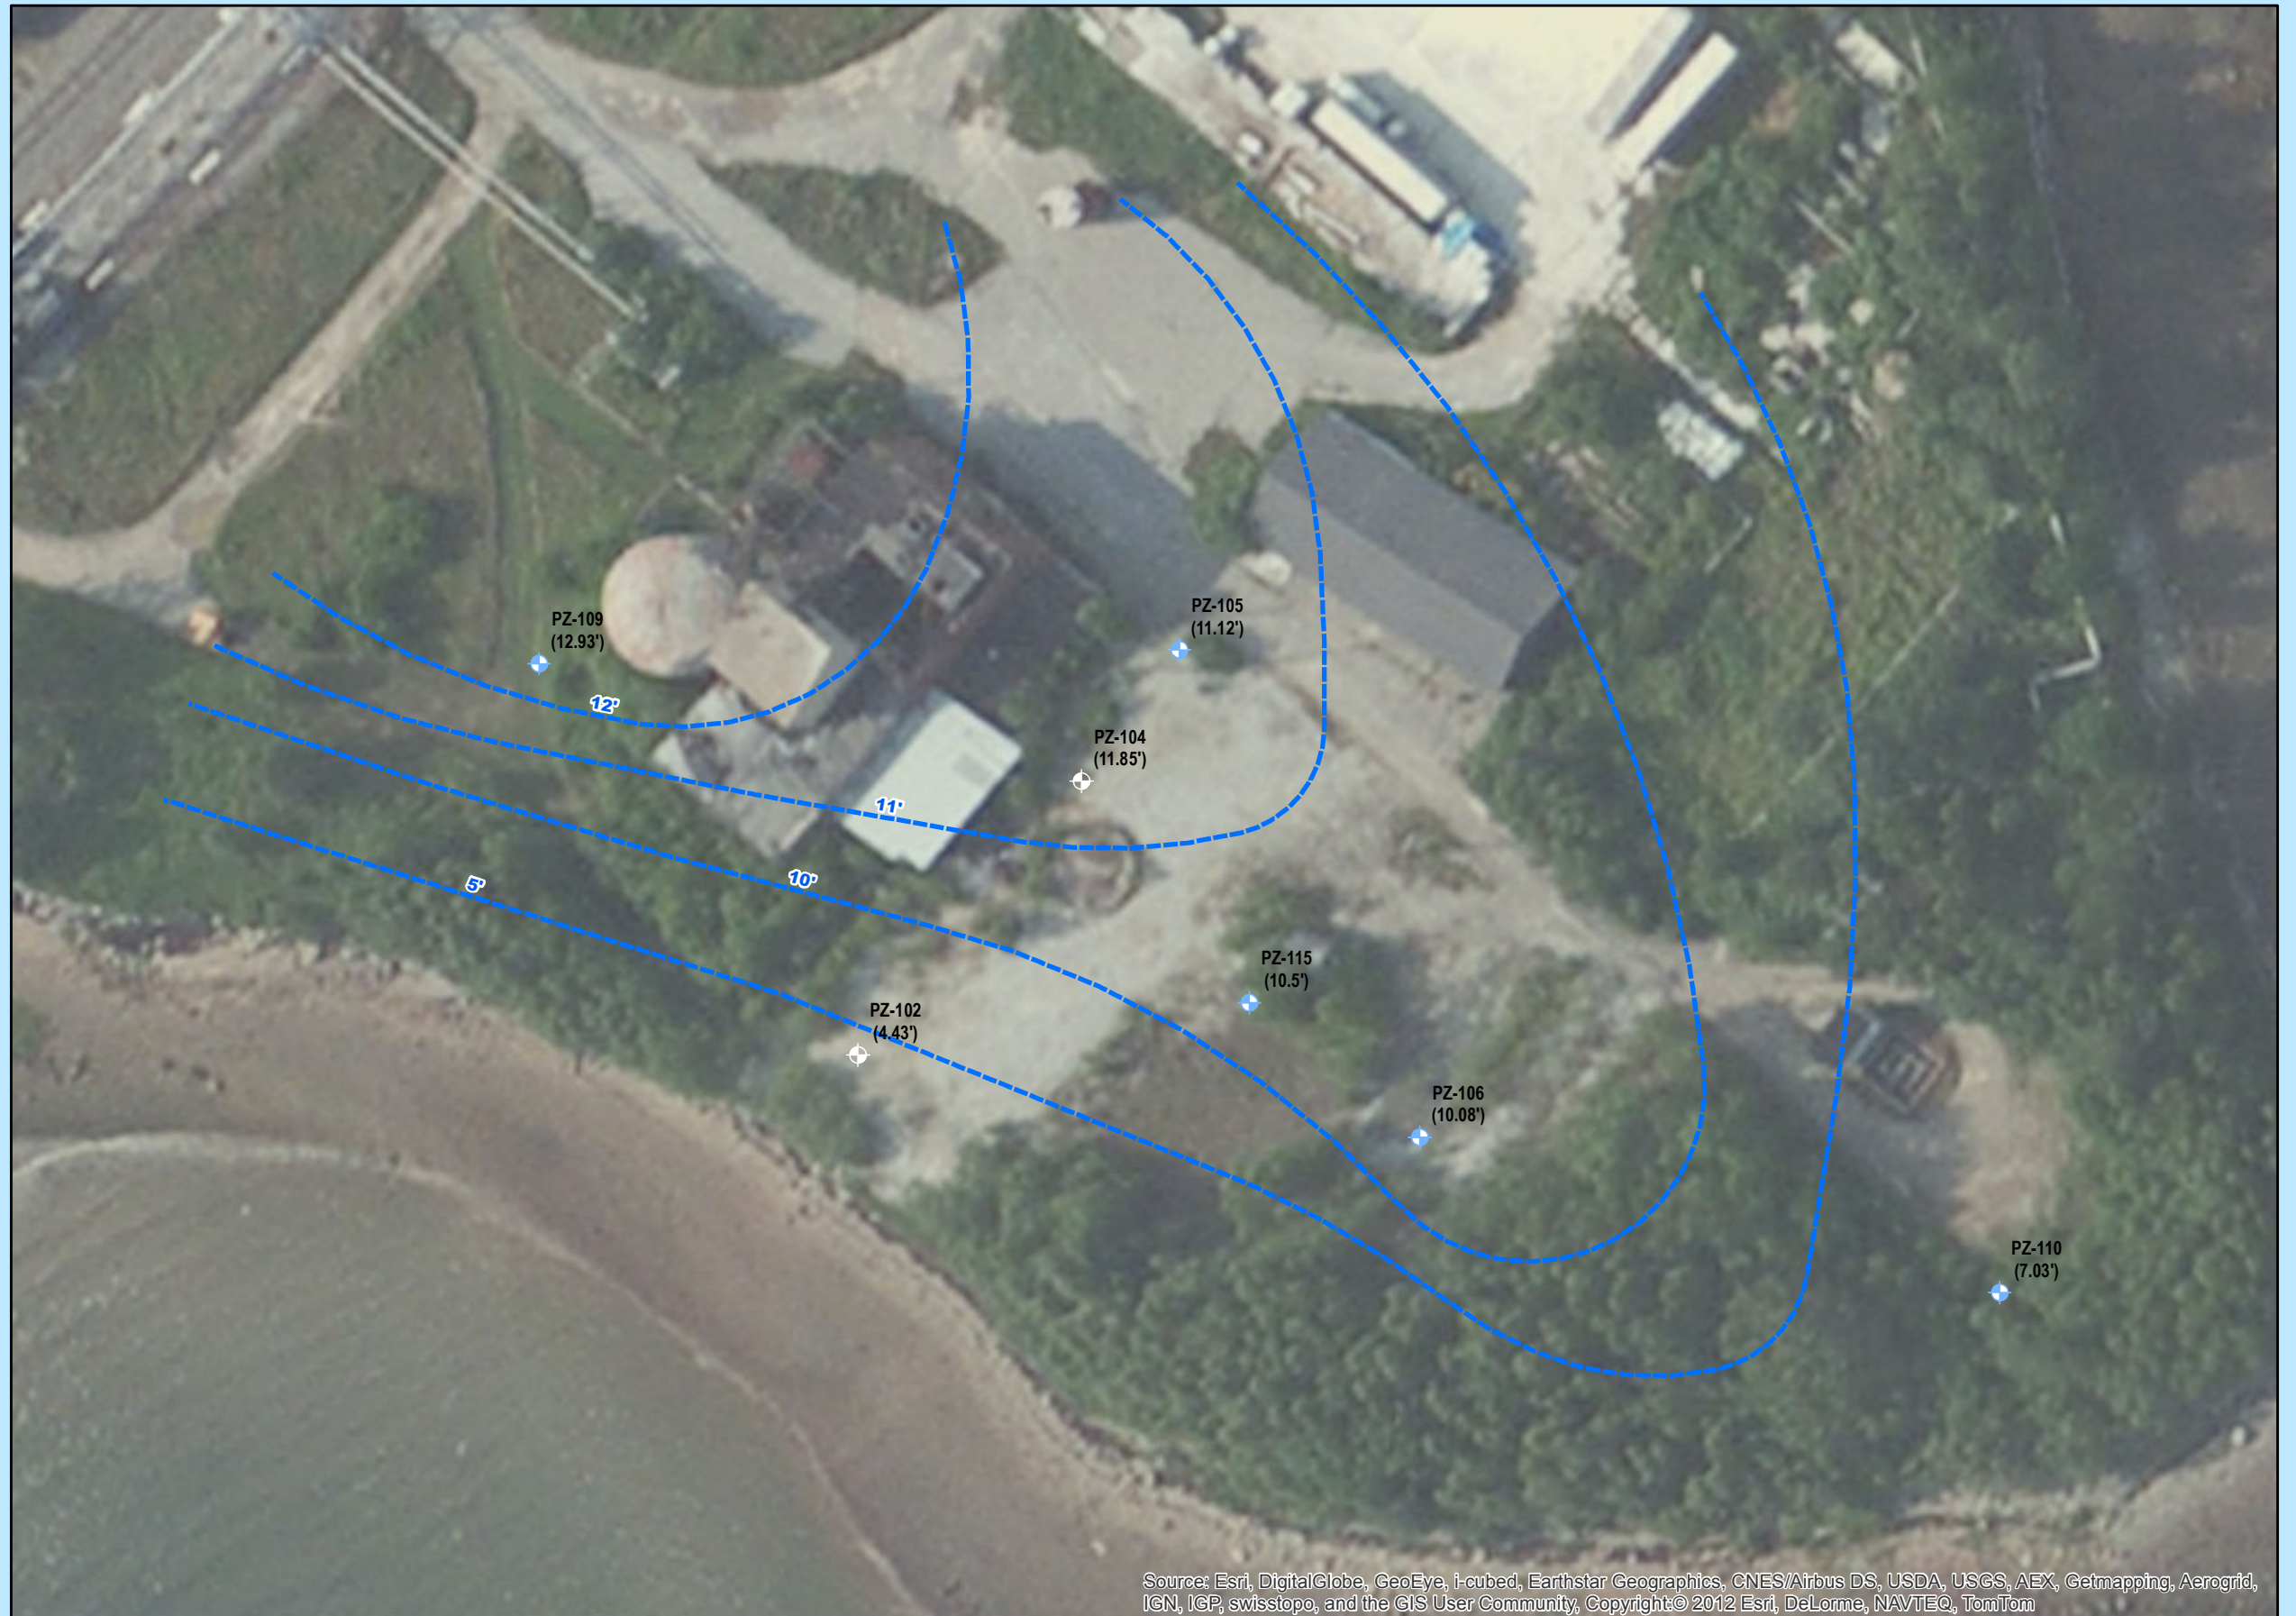
**FIGURE 6**  
**GROUNDWATER CONTOUR MAP**

With the exception of piezometer PZ-102, each of the piezometers show a response to tidal fluctuation on the order of 0.4 to 0.9 feet (higher water table elevation corresponds to high tide). Water table elevations during the high tide cycle were used to interpret groundwater flow patterns. Refer to **Figure 6** for a groundwater contour map. As shown on **Figure 6** groundwater flow generally mimics topography with flow from the topographic highs of the peninsula toward Stockton Harbor. However, it should be noted that PZ-105 appears to be northeast of a groundwater divide with flow from PZ-105 interpreted to be northeasterly.

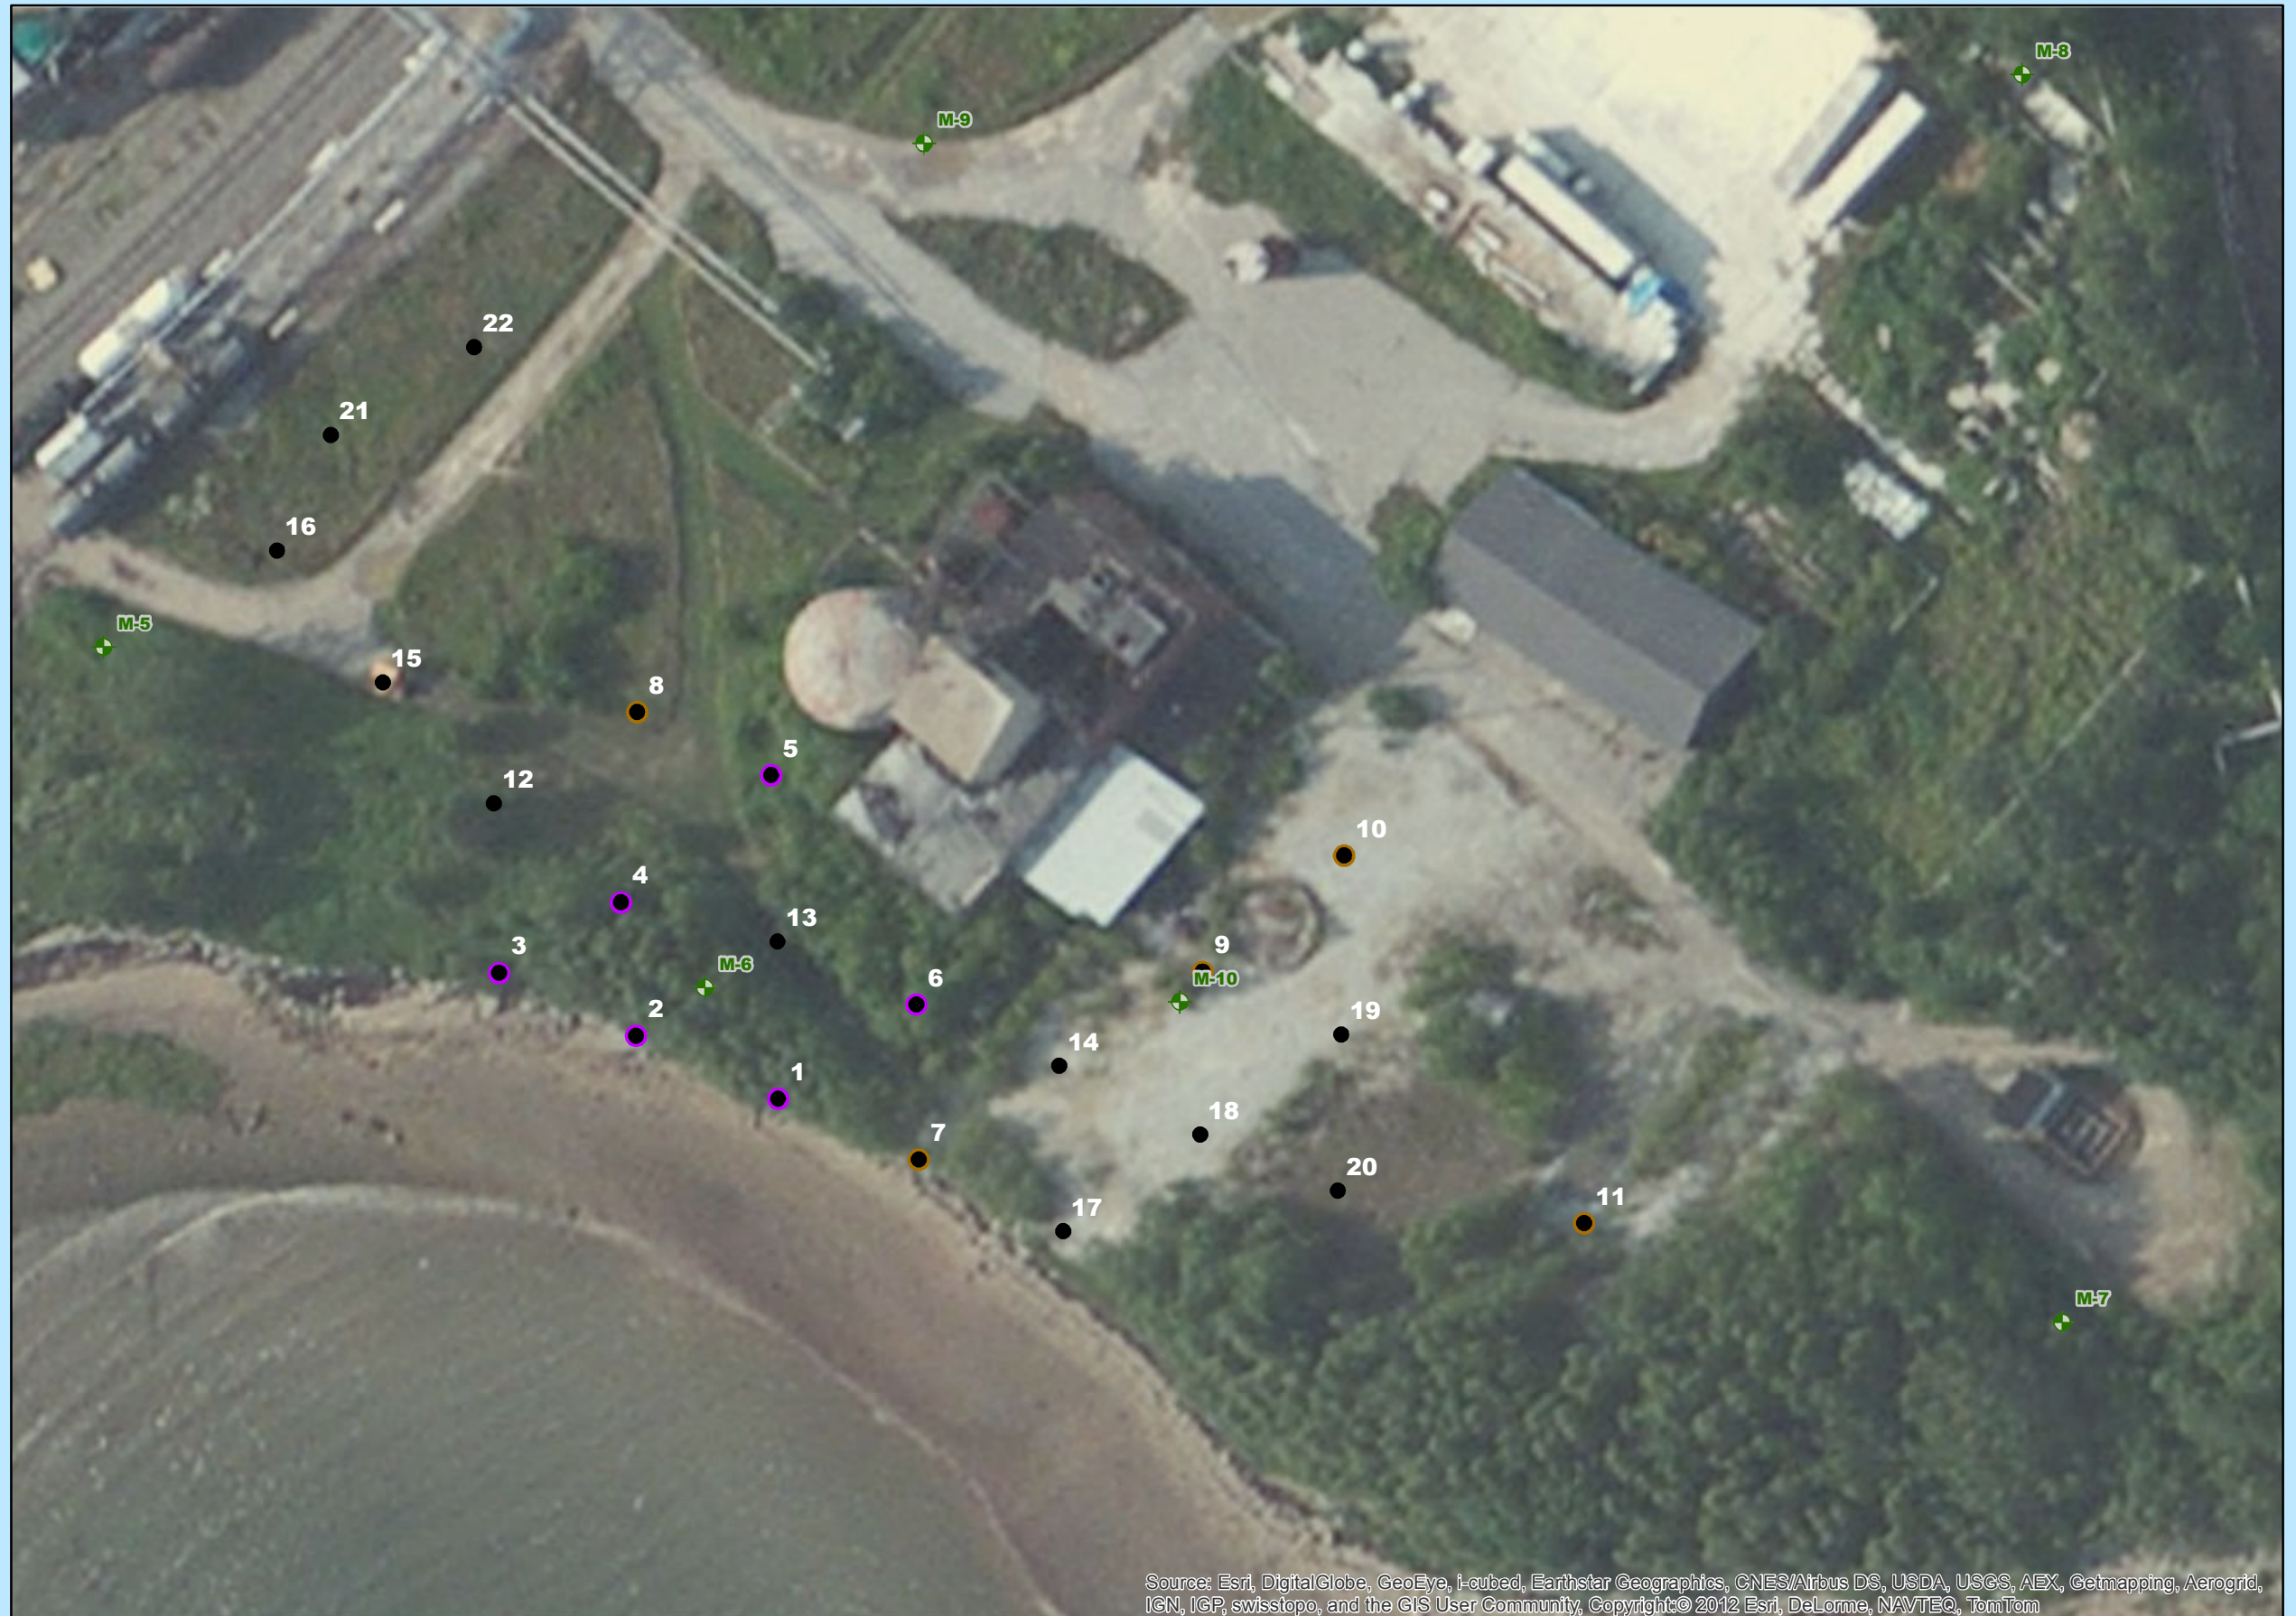
- 1: SITE DATA DEVELOPED BY CES, INC. MAPPING IS INTENDED FOR REFERENCE PURPOSES ONLY.
- 2: SAMPLES IDENTIFIED AS "SW" INDICATE SURFACE WATER SAMPLE LOCATIONS. COLLECTED 8/29/2014.
- 3: SAMPLES IDENTIFIED AS "PW" INDICATE PORE WATER SAMPLE LOCATIONS. COLLECTED 8/29/2014.
- 4: HISTORICAL GROUNDWATER SULFATE LEVELS FROM A HISTORIC EC JORDAN SAMPLING PLAN, 1984.
- 5: MAP IS PROJECTED USING MAINE STATE PLANE COORDINATES, EAST ZONE, LINEAR UNITS OF SURVEY FEET AND REFERENCES THE NORTH AMERICAN DATUM OF 1983 (NAD83).
- 6: NORTH ARROW IS REFERENCED TO GRID NORTH.

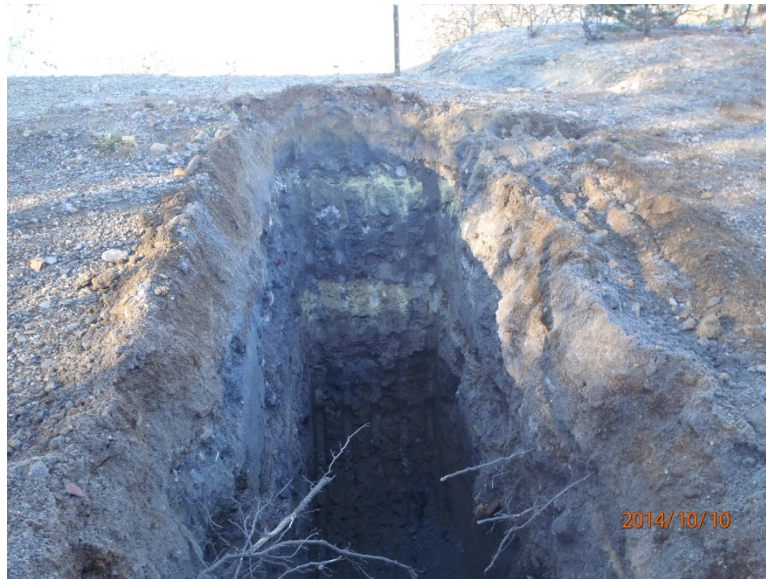
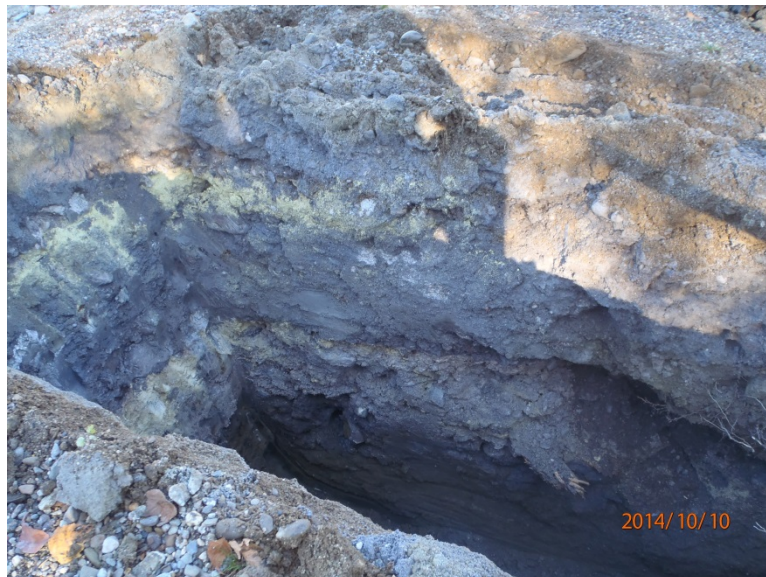
### TEST PIT LOG

<b>Project No:</b> 10060.007	<b>Project Description:</b> GAC – Test Pitting	<b>Date:</b> 10/10/2014
<b>Test Pit No:</b> TP-101	<b>Contractor/Operator:</b>	<b>Logged by:</b> BS
<b>Location / Notes:</b> See figure for test pit locations		
Depth	Description of Soils	Comments
0-12"	Gray gravel coarse sand	
12-20"	Sulfur material	
20-34"	Gray gravel silt fine sand	
34-44"	Sulfur material	
44-58"	Gray gravel silt	
58-88"	Brown fine sand silt

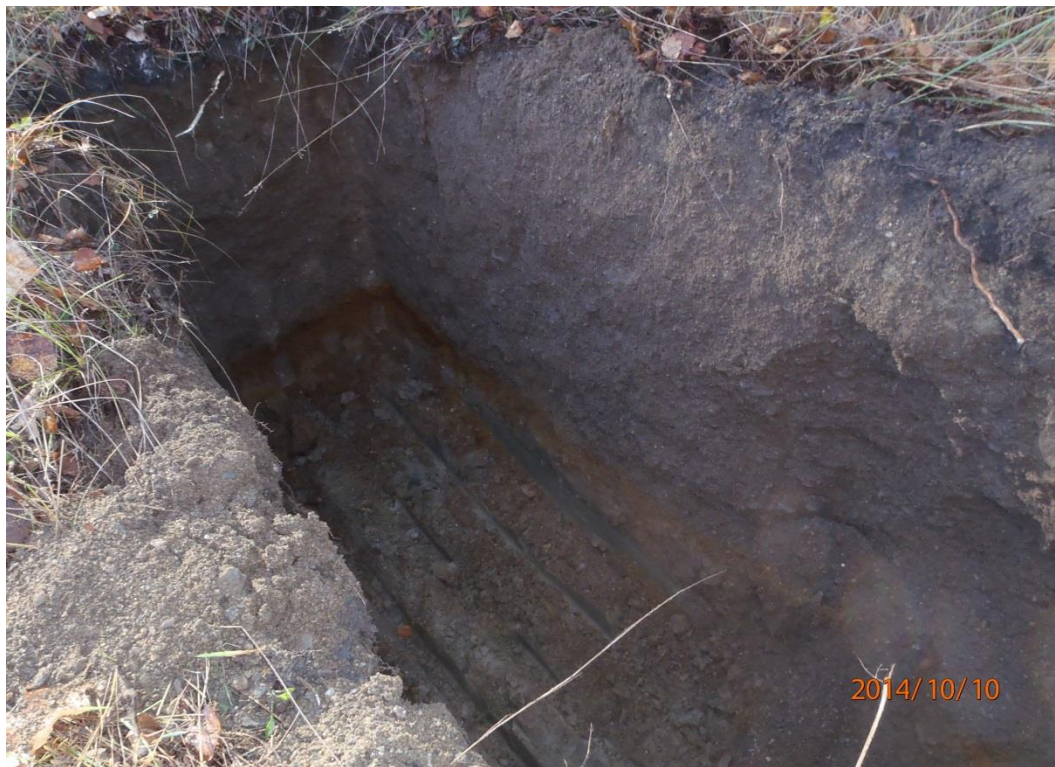
### TEST PIT LOG

<b>Project No:</b> 10060.007	<b>Project Description:</b> GAC – Test Pitting	<b>Date:</b> 10/10/2014
<b>Test Pit No:</b> TP-102	<b>Contractor/Operator:</b>	<b>Logged by:</b> BS
<b>Location / Notes:</b> See figure for test pit locations		
<b>Depth</b>	<b>Description of Soils</b>	<b>Comments</b>
0-22"	Brown medium sand	
22-26"	Orange medium sand	
26-32"	Brown silt clay	Small block of sulfur
		Observed at silt clay interface

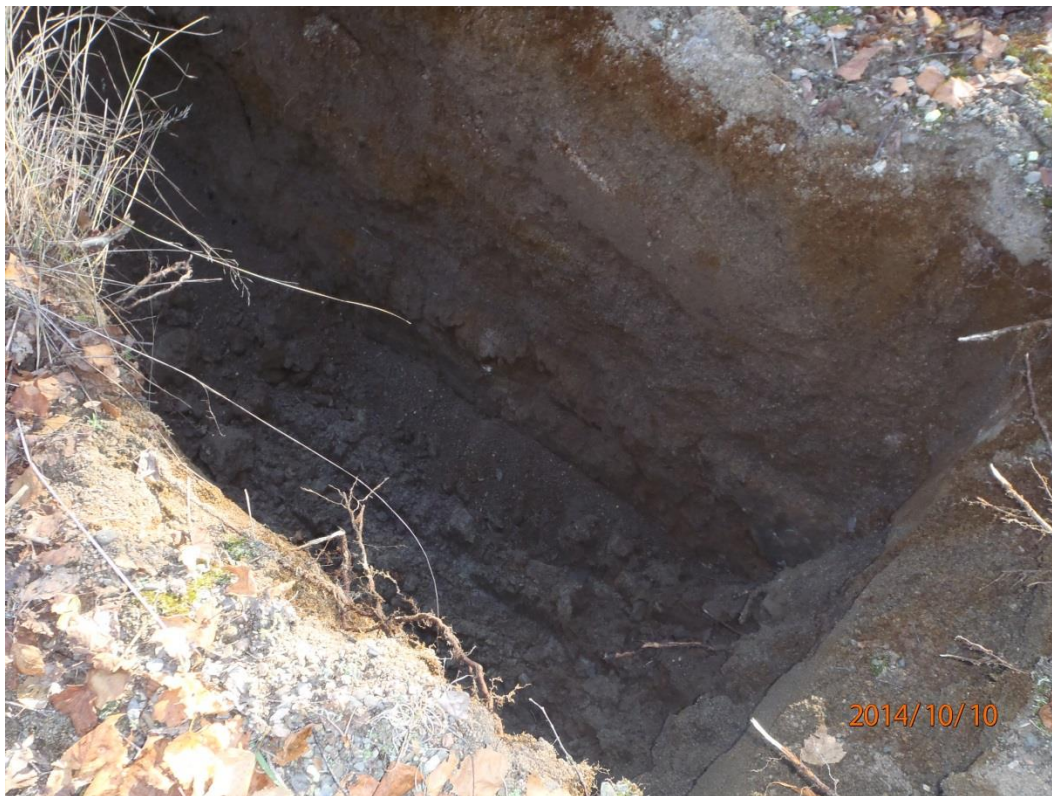
### TEST PIT LOG

<b>Project No:</b> 10060.007	<b>Project Description:</b> GAC – Test Pitting	<b>Date:</b> 10/10/2014
<b>Test Pit No:</b> TP-103	<b>Contractor/Operator:</b>	<b>Logged by:</b> BS
<b>Location / Notes:</b> See figure for test pit locations		
Depth	Description of Soils	Comments
0-2"	Orange coarse sand	
2-16"	Brown medium sand	
16-26"	Brown silt clay

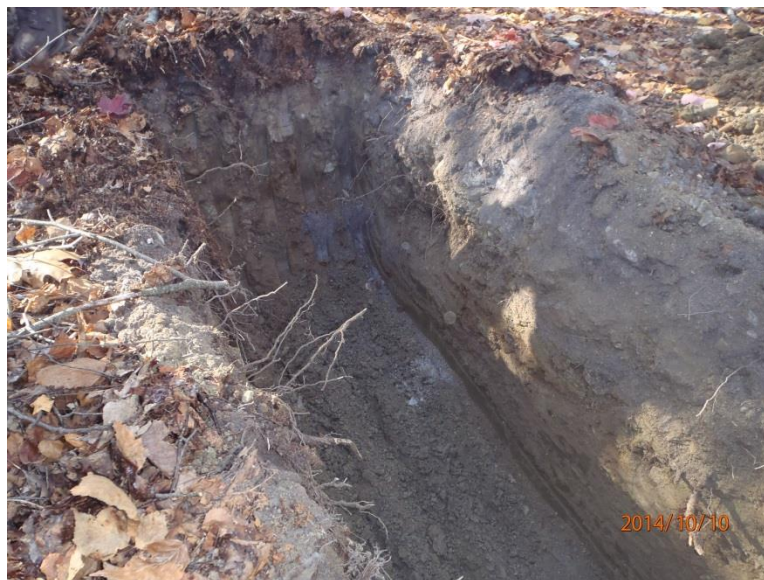
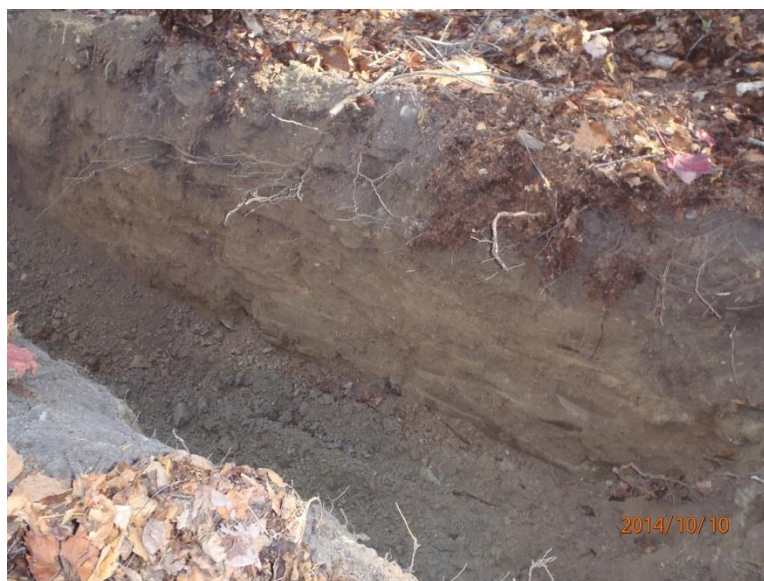
### TEST PIT LOG

<b>Project No:</b> 10060.007	<b>Project Description:</b> GAC – Test Pitting	<b>Date:</b> 10/10/2014
<b>Test Pit No:</b> TP-104	<b>Contractor/Operator:</b>	<b>Logged by:</b> BS
<b>Location / Notes:</b> See figure for test pit locations		
Depth	Description of Soils	Comments
0-4"	Gray light brown gravel medium sand	
4-16"	Brown sand silt	
16-24"	Dark brown sand silt

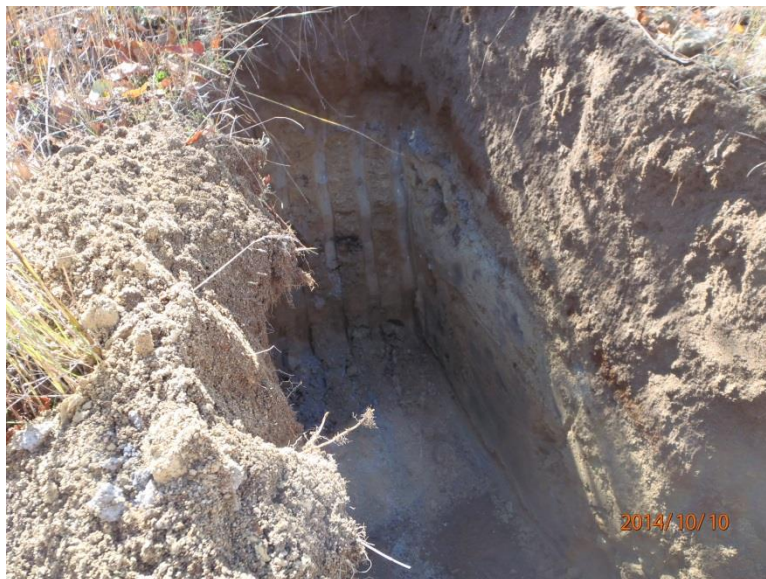
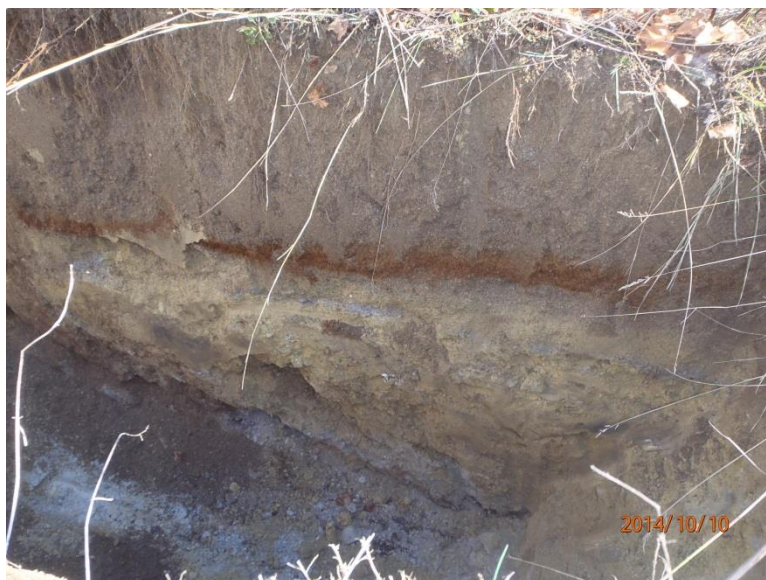
### TEST PIT LOG

Depth	Description of Soils	Comments
0-14"	Brown coarse sand	
14-16"	Orange coarse sand	
16-18"	Gray coarse sand	Block of sulfur observed
18-24"	Light brown silt fine sand	
24-38"	Brown silt fine sand
