**INVESTIGATIONS SUMMARY REPORT  
VOLUNTARY RESPONSE ACTION PROGRAM  
34 KIDDER POINT ROAD  
SEARSPORT, MAINE**

**NOVEMBER 2014  
JN: 10060.007**

## INVESTIGATIONS SUMMARY REPORT VOLUNTARY RESPONSE ACTION PROGRAM GAC CHEMICAL

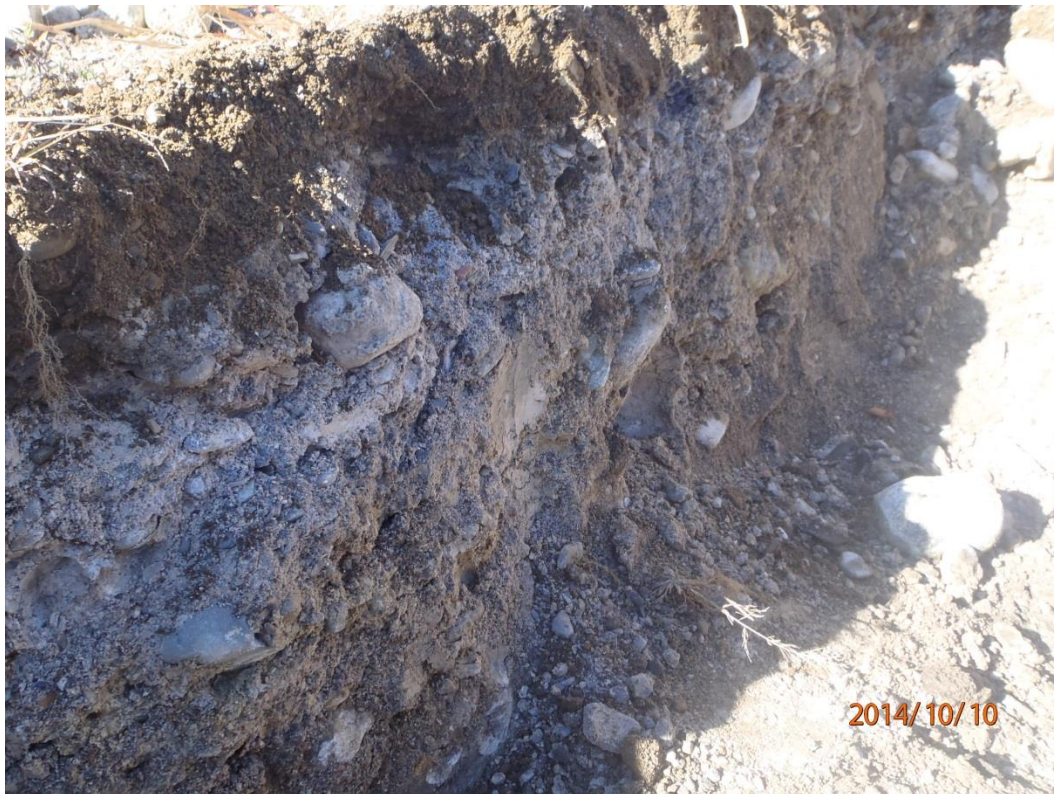
### TEST PIT LOG

<b>Project No:</b> 10060.007	<b>Project Description:</b> GAC – Test Pitting	<b>Date:</b> 10/10/2014
<b>Test Pit No:</b> TP-107	<b>Contractor/Operator:</b>	<b>Logged by:</b> BS
<b>Location / Notes:</b> See figure for test pit locations		
<b>Depth</b>	<b>Description of Soils</b>	<b>Comments</b>
0-4"	Brown gravel coarse sand	
4-14"	Gray gravel coarse sand	
14-18"	Gray gravel coarse sand	Cementitious
18-22"	Dark gray gravel coarse sand	
-	Refusal	Cementitious

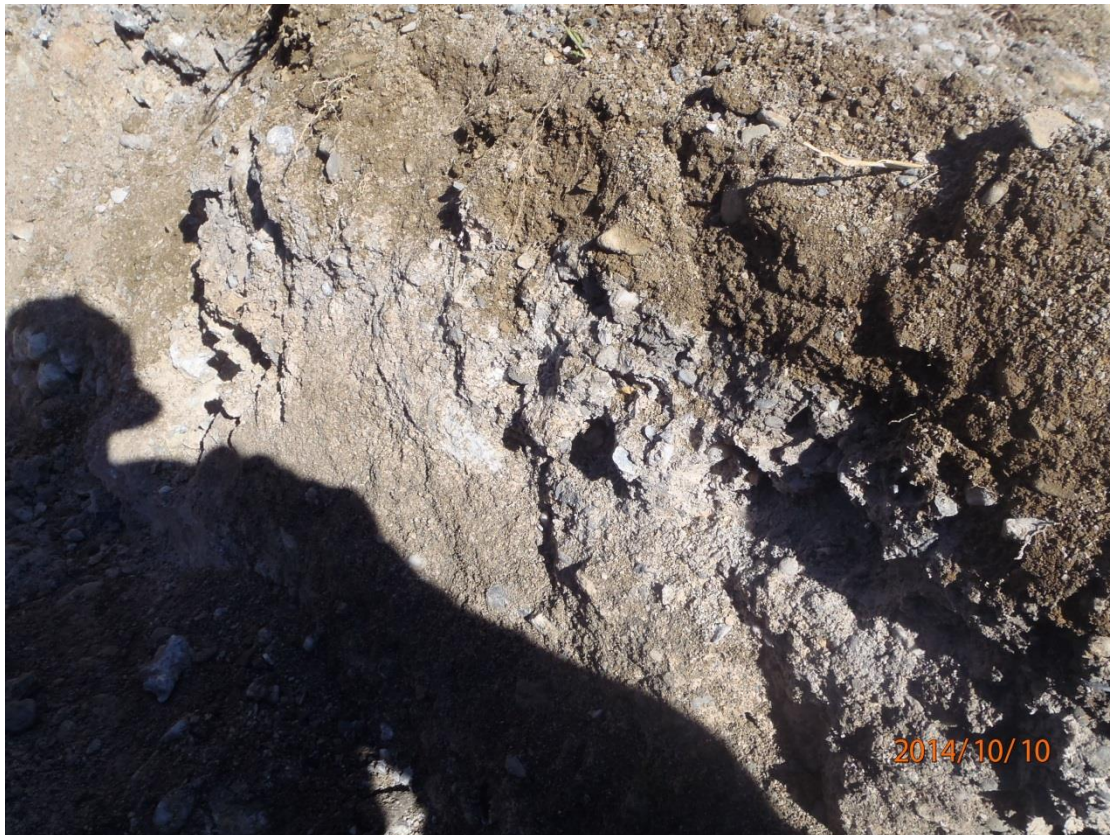
### TEST PIT LOG

<b>Project No:</b> 10060.007	<b>Project Description:</b> GAC – Test Pitting	<b>Date:</b> 10/10/2014
<b>Test Pit No:</b> TP-108	<b>Contractor/Operator:</b>	<b>Logged by:</b> BS
<b>Location / Notes:</b> See figure for test pit locations		
<b>Depth</b>	<b>Description of Soils</b>	<b>Comments</b>
0-4"	Gray gravel coarse sand	
4-7"	Yellow gravel coarse sand	Sulfur
7-24"	Gray gravel coarse sand	
24-28"	Gray gravel coarse sand	Cementitious
28-42"	Dark brown black silt clay	
42-50"	Blue/brown/green clay

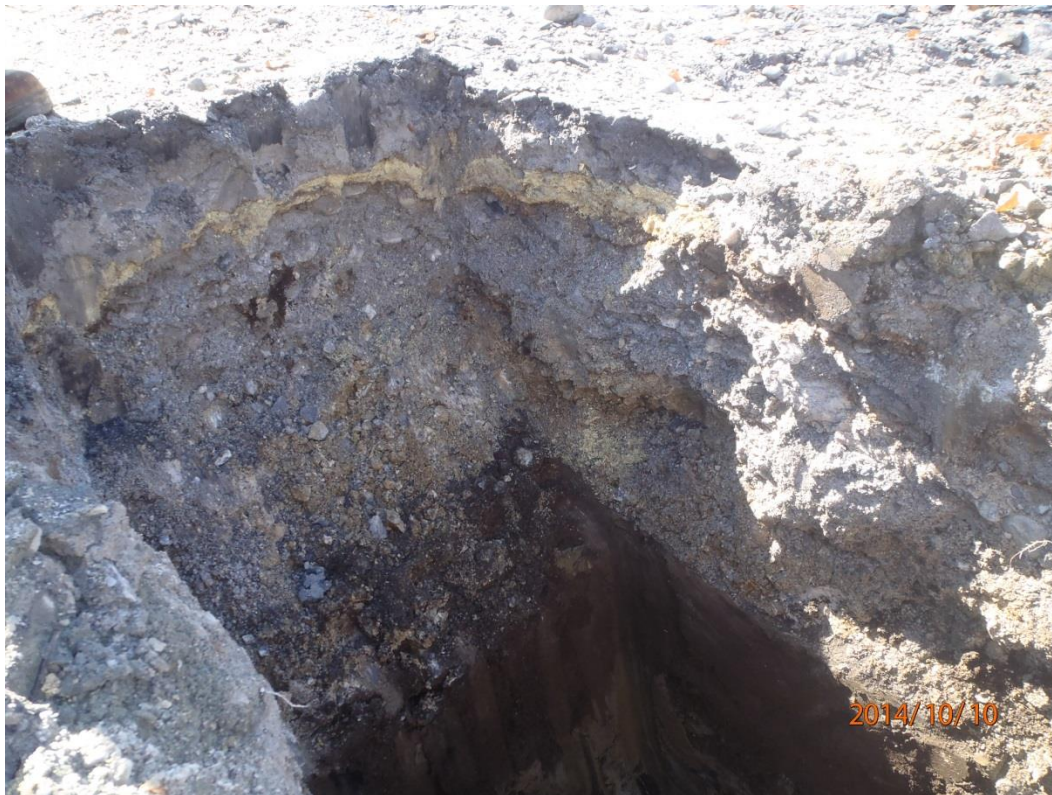
### TEST PIT LOG

<b>Project No:</b> 10060.007	<b>Project Description:</b> GAC – Test Pitting	<b>Date:</b> 10/10/2014
<b>Test Pit No:</b> TP-109	<b>Contractor/Operator:</b>	<b>Logged by:</b> BS
<b>Location / Notes:</b> See figure for test pit locations		
<b>Depth</b>	<b>Description of Soils</b>	<b>Comments</b>
0-5"	Brown gravel coarse sand	
5-8"	Gray gravel coarse sand	
8-14"	Yellow gravel coarse sand	Sulfur
14-22"	Gray gravel coarse sand	
22-28"	Rock /gravel	Cementitious
28-38"	Black silt sand	
38-50"	Brown silt clay

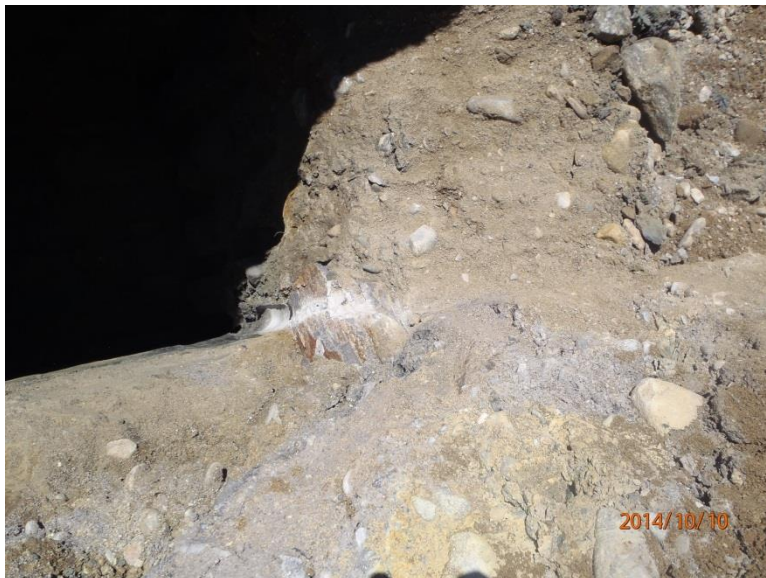
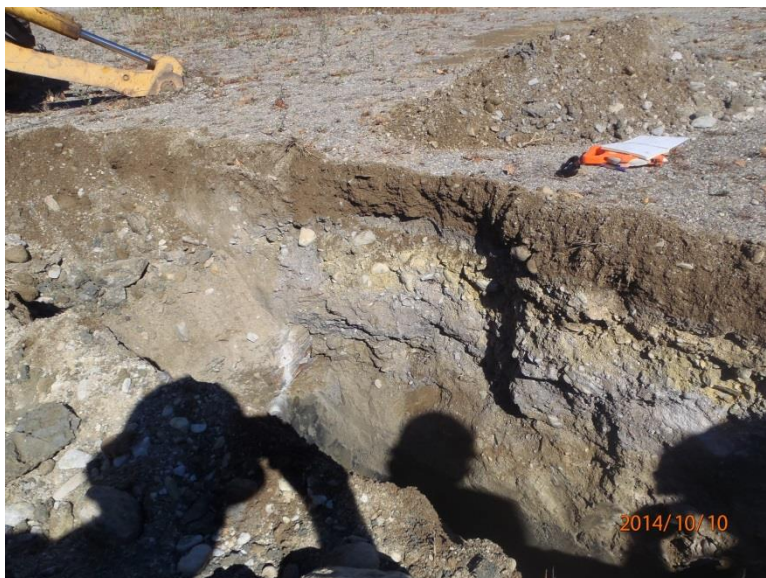
### TEST PIT LOG

Depth	Description of Soils	Comments
0-4"	Brown gravel coarse sand	
4-7"	Gray gravel coarse sand	
7-15"	Yellow gravel coarse sand	Sulfur
15-18"	Gray gravel coarse sand	
18-24"	Rock /gravel	Cementitious
24-34"	Brown gravel coarse sand

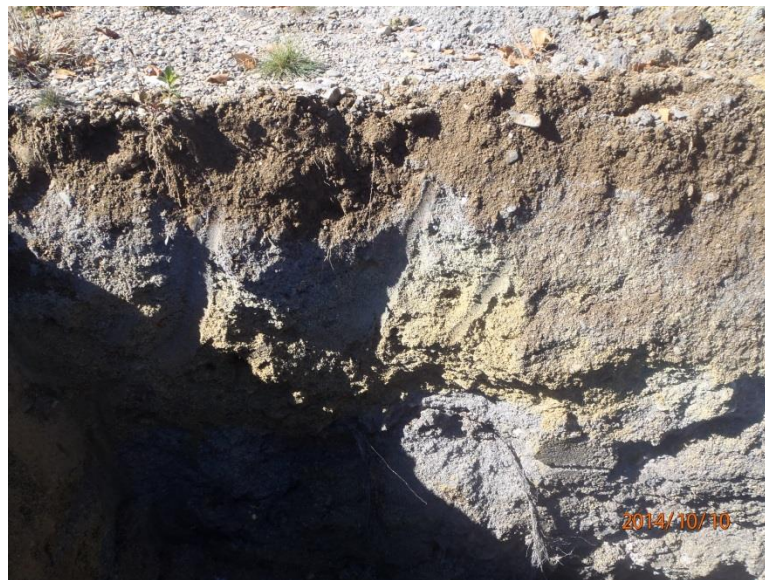
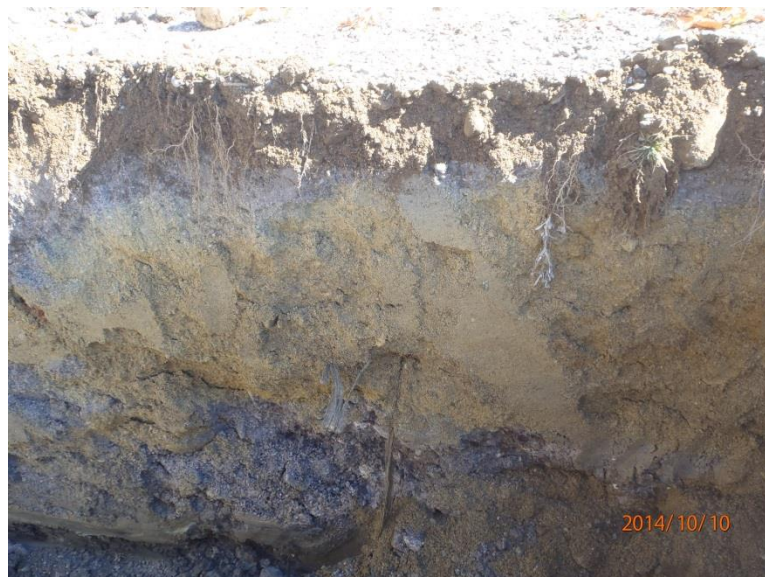
### TEST PIT LOG

<b>Project No:</b> 10060.007	<b>Project Description:</b> GAC – Test Pitting	<b>Date:</b> 10/10/2014
<b>Test Pit No:</b> TP-111	<b>Contractor/Operator:</b>	<b>Logged by:</b> BS
<b>Location / Notes:</b> See figure for test pit locations		
Depth	Description of Soils	Comments
0-3"	Brown gravel coarse sand	
3-7"	Gray gravel coarse sand	
7-15"	Light brown yellow gravel coarse sand	Sulfur
15-31"	Gray gravel coarse sand	
31-35"	Rock /gravel	Cementitious
35-37"	Black fine sand silt	
37-47"	Brown gray green clay

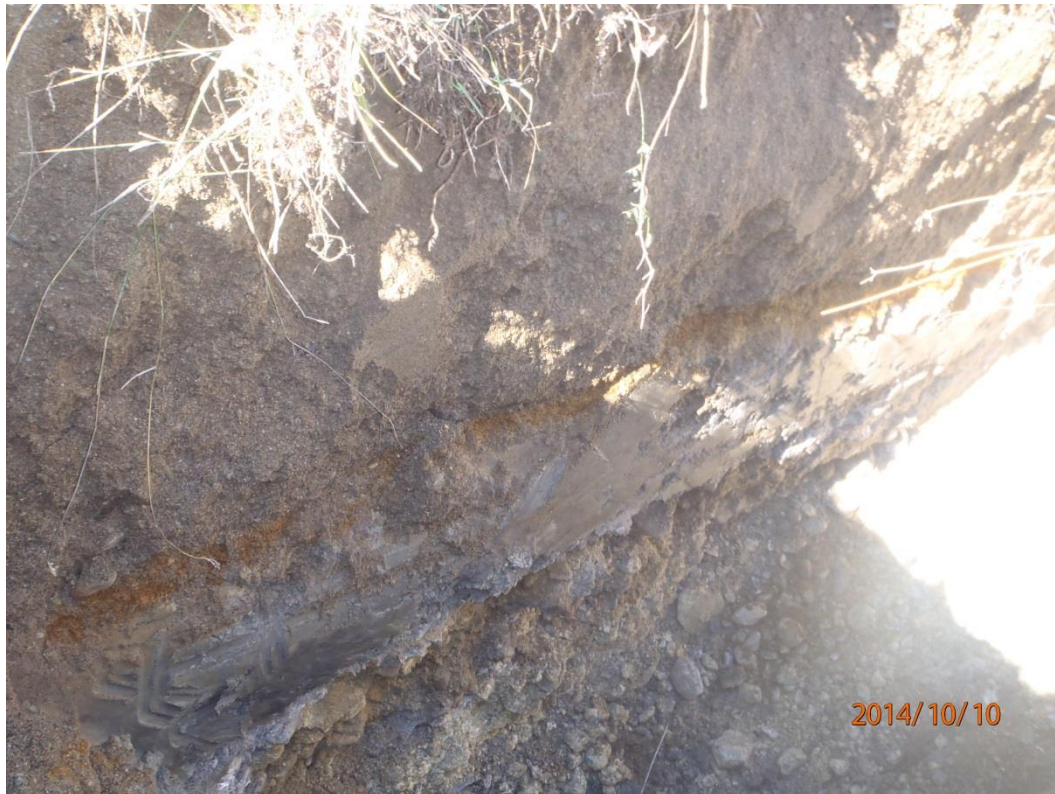
### TEST PIT LOG

<b>Project No:</b> 10060.007	<b>Project Description:</b> GAC – Test Pitting	<b>Date:</b> 10/10/2014
<b>Test Pit No:</b> TP-112	<b>Contractor/Operator:</b>	<b>Logged by:</b> BS
<b>Location / Notes:</b> See figure for test pit locations		
Depth	Description of Soils	Comments
0-24"	Brown gravel coarse sand	
24-37"	Dark brown silt clay	
37-55"	Gray gravel coarse sand	
55-57"	Gray brown gravel coarse sand	Cementitious

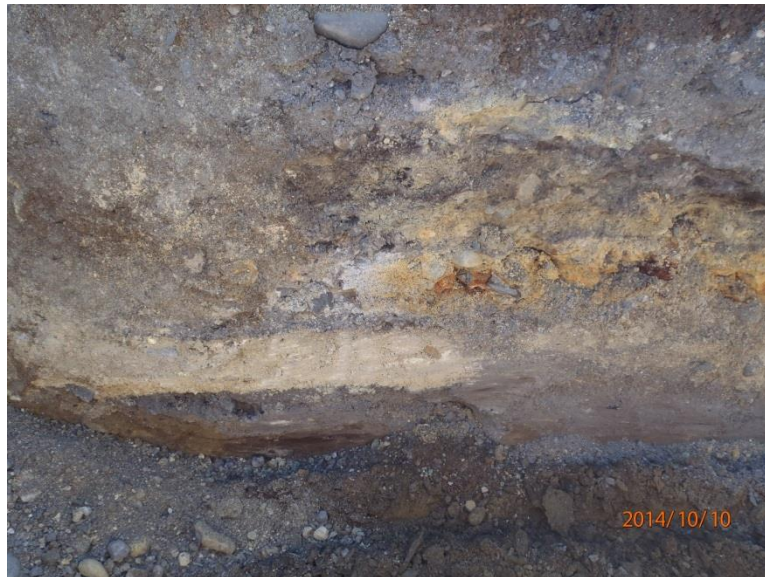
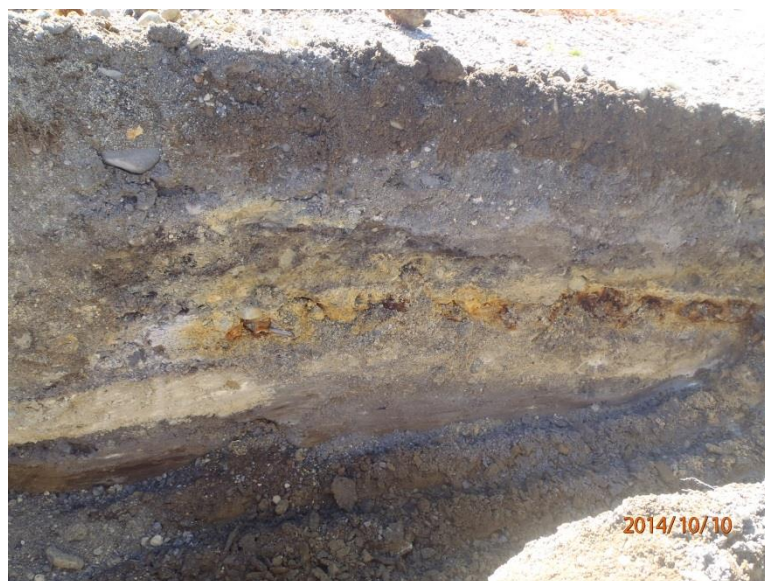
### TEST PIT LOG

<b>Project No:</b> 10060.007	<b>Project Description:</b> GAC – Test Pitting	<b>Date:</b> 10/10/2014
<b>Test Pit No:</b> TP-113	<b>Contractor/Operator:</b>	<b>Logged by:</b> BS
<b>Location / Notes:</b> See figure for test pit locations		
Depth	Description of Soils	Comments
0-3"	Brown gravel coarse sand	
3-13"	Gray gravel coarse sand	
13-29"	Yellow gravel coarse sand	Sulfur
29-37"	Dark brown gravel sand silt

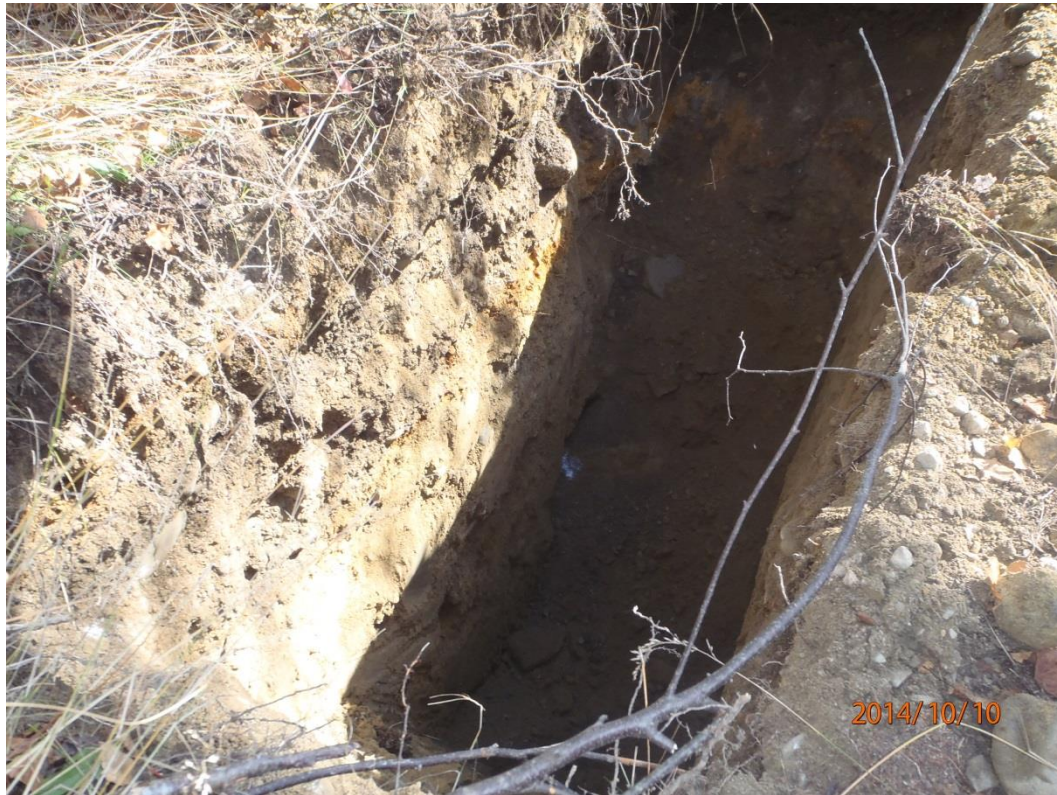
### TEST PIT LOG

<b>Project No:</b> 10060.007	<b>Project Description:</b> GAC – Test Pitting	<b>Date:</b> 10/10/2014
<b>Test Pit No:</b> TP-114	<b>Contractor/Operator:</b>	<b>Logged by:</b> BS
<b>Location / Notes:</b> See figure for test pit locations		
Depth	Description of Soils	Comments
0-10"	Dark brown loam silt sand	
10-72"	Brown loam silt sand

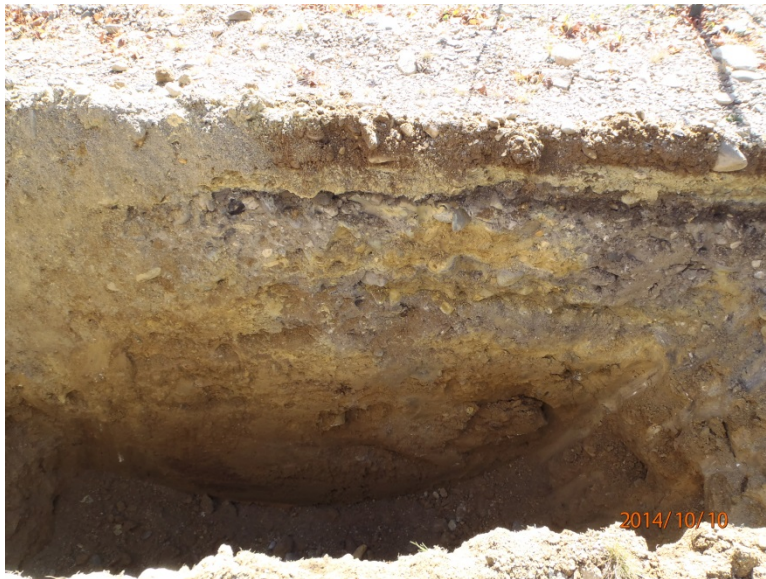
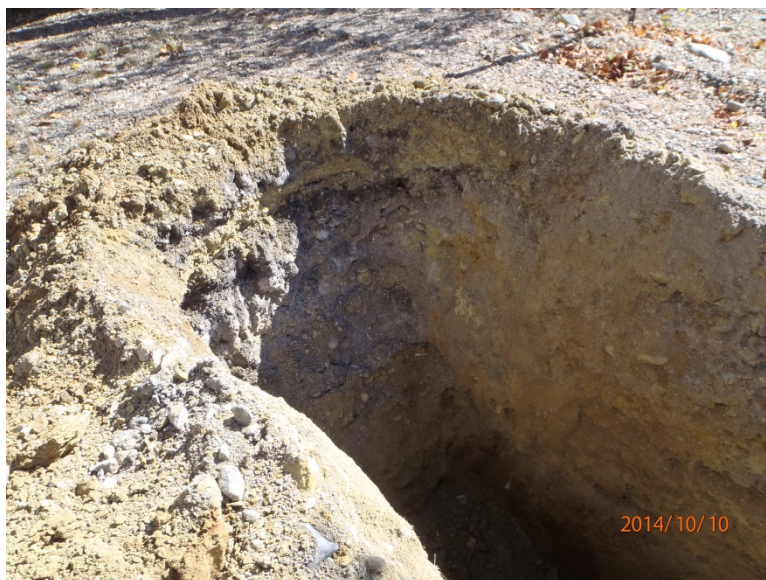
### TEST PIT LOG

Depth	Description of Soils	Comments
0-2"	Brown gravel coarse sand	
2-4"	Yellow gravel coarse sand	Sulfur
4-7"	Dark gray gravel coarse sand	
7-23"	Gray yellow gravel coarse sand	Sulfur
23-57"	Brown loam silt sand
