Phase I Environmental Site Assessment Former Maine State Prison Site Thomaston, Maine

Phase I Environmental Site Assessment Former Maine State Prison Site, Thomaston, Maine

Phase I Environmental Site Assessment

Former Maine State Prison Site, Thomaston, Maine

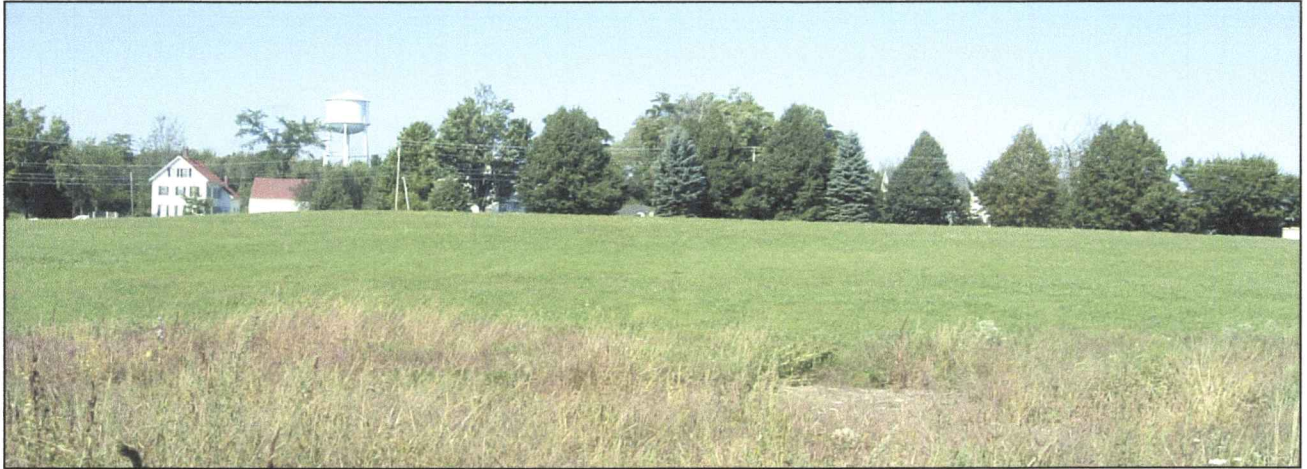
1. View to north across field from top of slope. Trees and buildings are on Main Street.

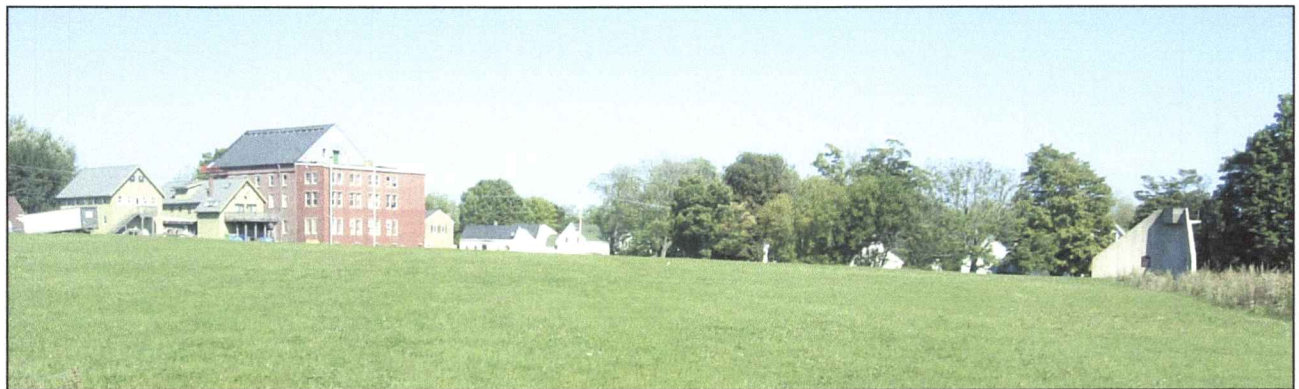
2. View to northeast across field. Brick building to left is former Prison Showroom. Concrete wall to east is memorial with plaques

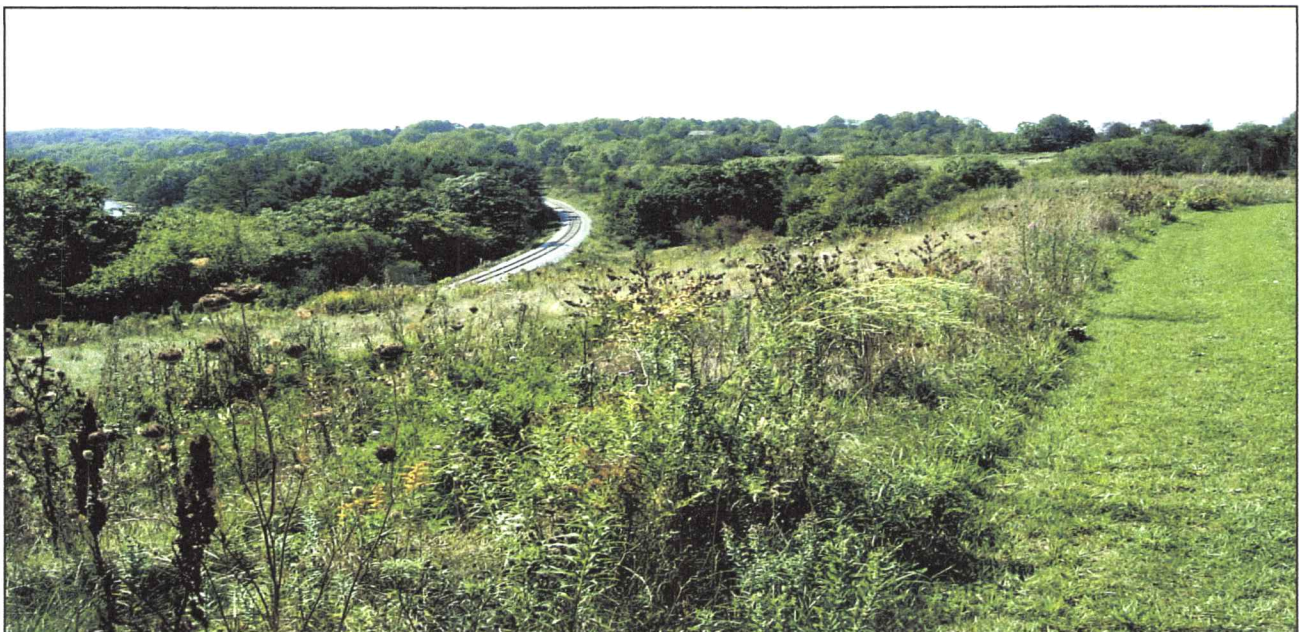
3. View southwest down slope from cemetery to railroad and river.
