Limited Assessment of Shoreline Erosion and Industrial Contamination  
at GAC Chemical Corporation

34 Kidder Point Road

Searsport, ME

August 1, 2025

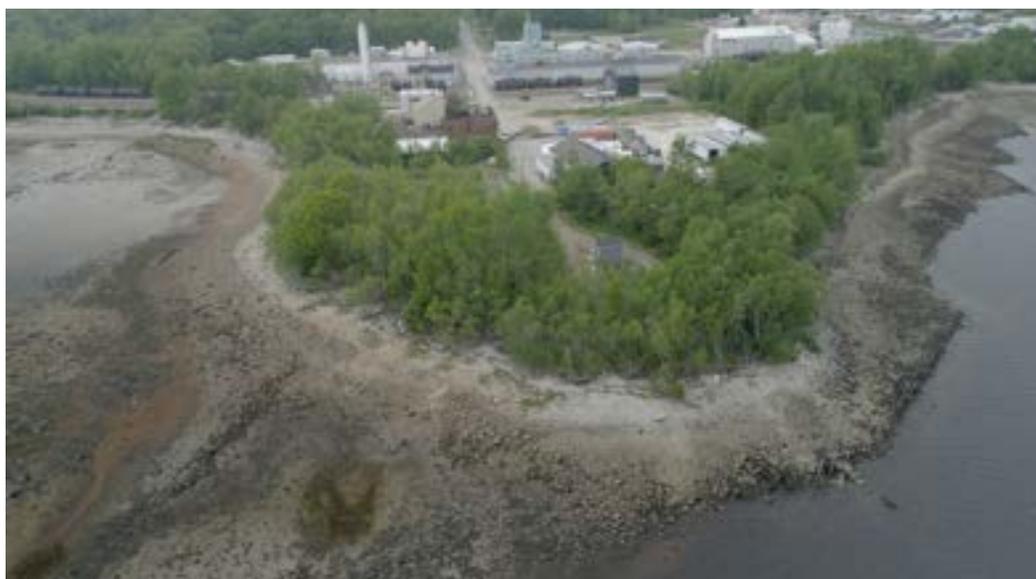
Photograph: View of Kidder Point, facing northwest.

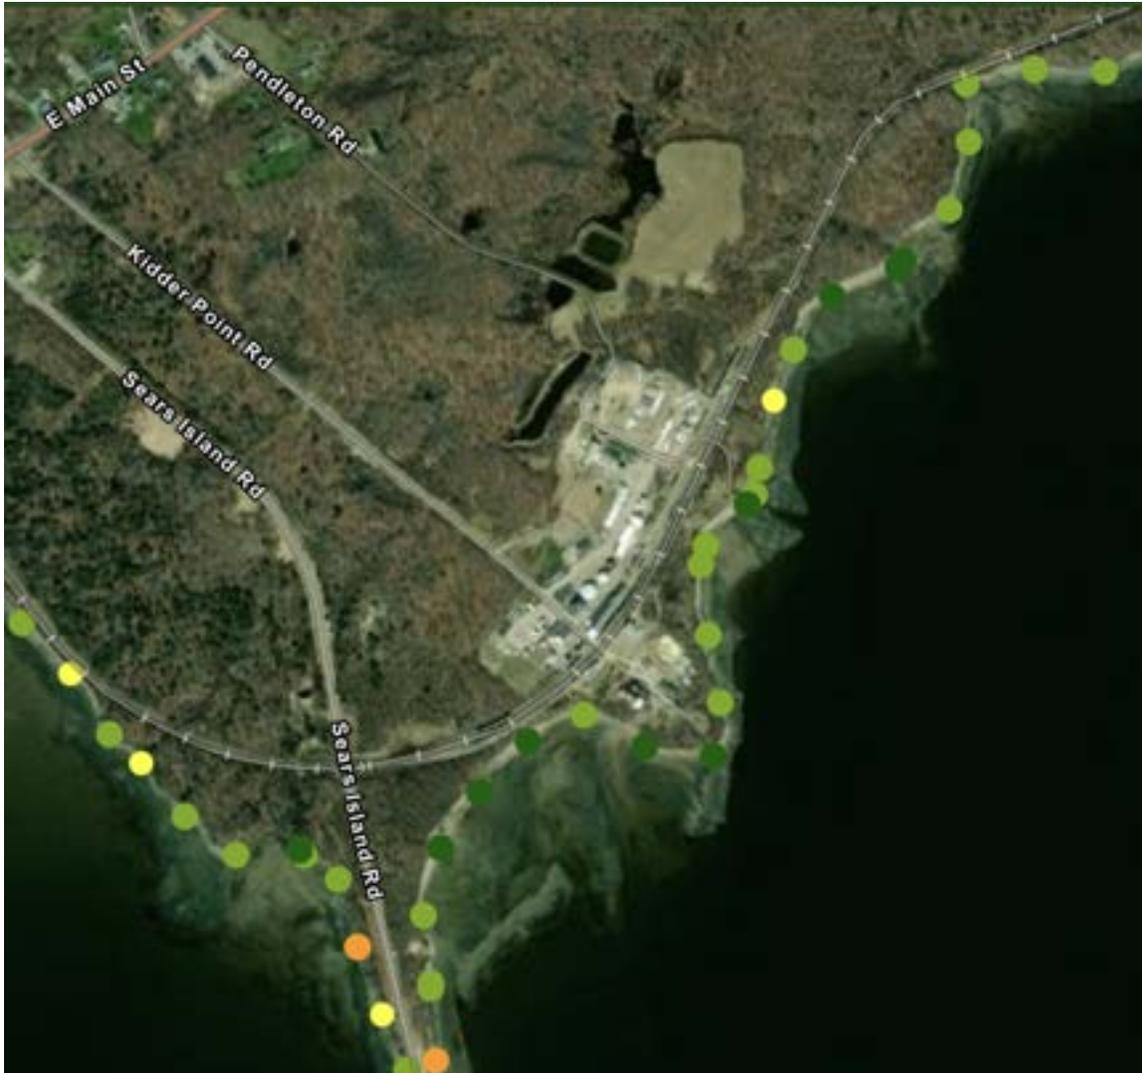
**Figure A4:** MGS Living Shorelines Decision Support Tool determines:  
The Maine Geological Survey reports that this site ranges from “highly suitable” (dark green) to “moderately” suitable (light green) and includes one small area that is “possibly suitable” (yellow).

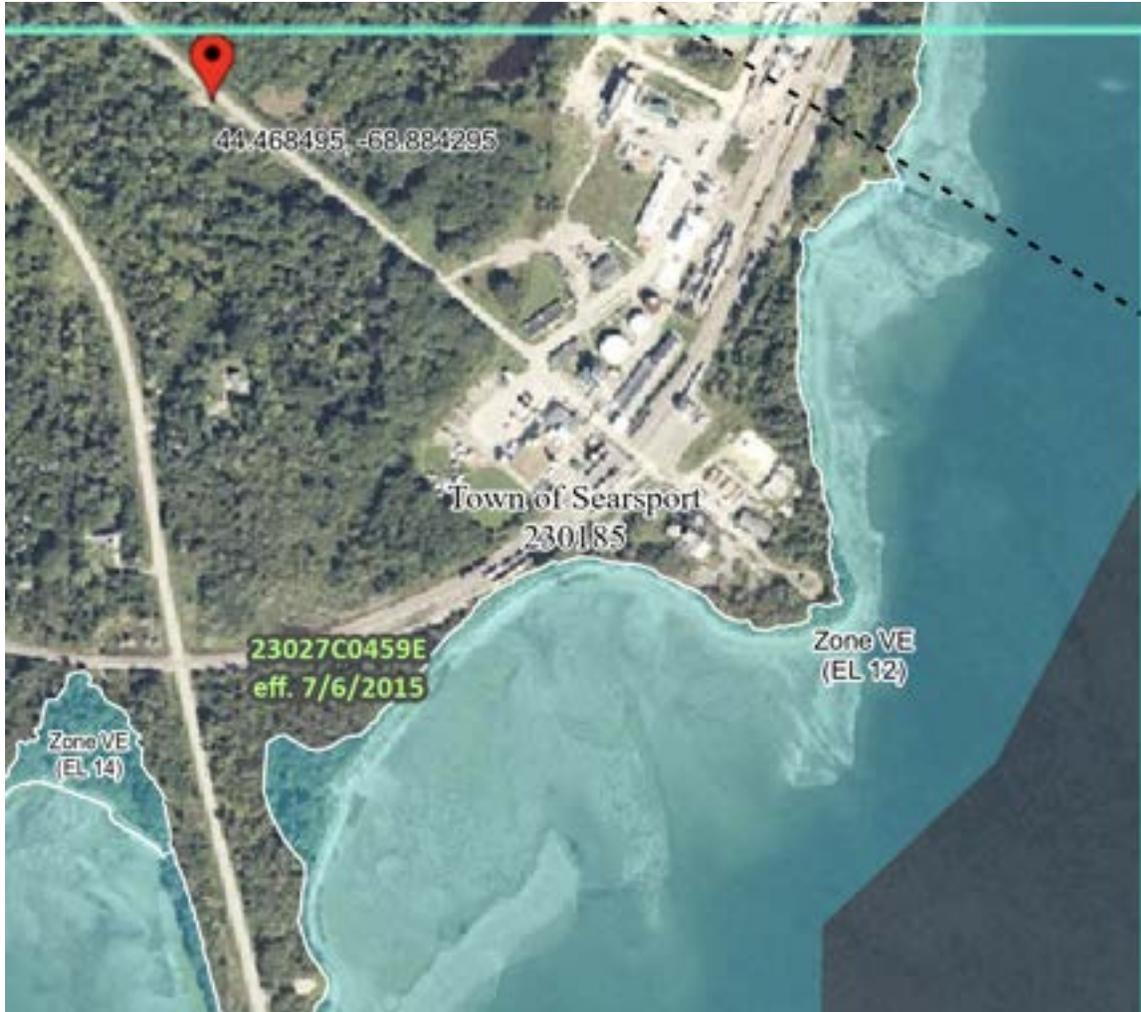
**Figure A5:** FEMA Flood Map Service Center- Zone VE (EL12)

"Zone VE EL 12" indicates a flood zone designation by the Federal Emergency Management Agency (FEMA), specifically a high-risk coastal area with a 1% annual chance of flooding and wave action. The "VE" part means it's a high-velocity, coastal flood zone, while "EL 12" signifies that the base flood elevation (the expected water level during a 1% annual chance flood) is 12 feet. This means that properties in this zone are at a higher risk of damage from both flooding and wave action.
