KIDDER POINT

LEGACY INDUSTRIAL
WASTE DUMPS

COASTAL
ACIDIFICATION
VECTOR

Friends of Penobscot Bay Pollution Watch

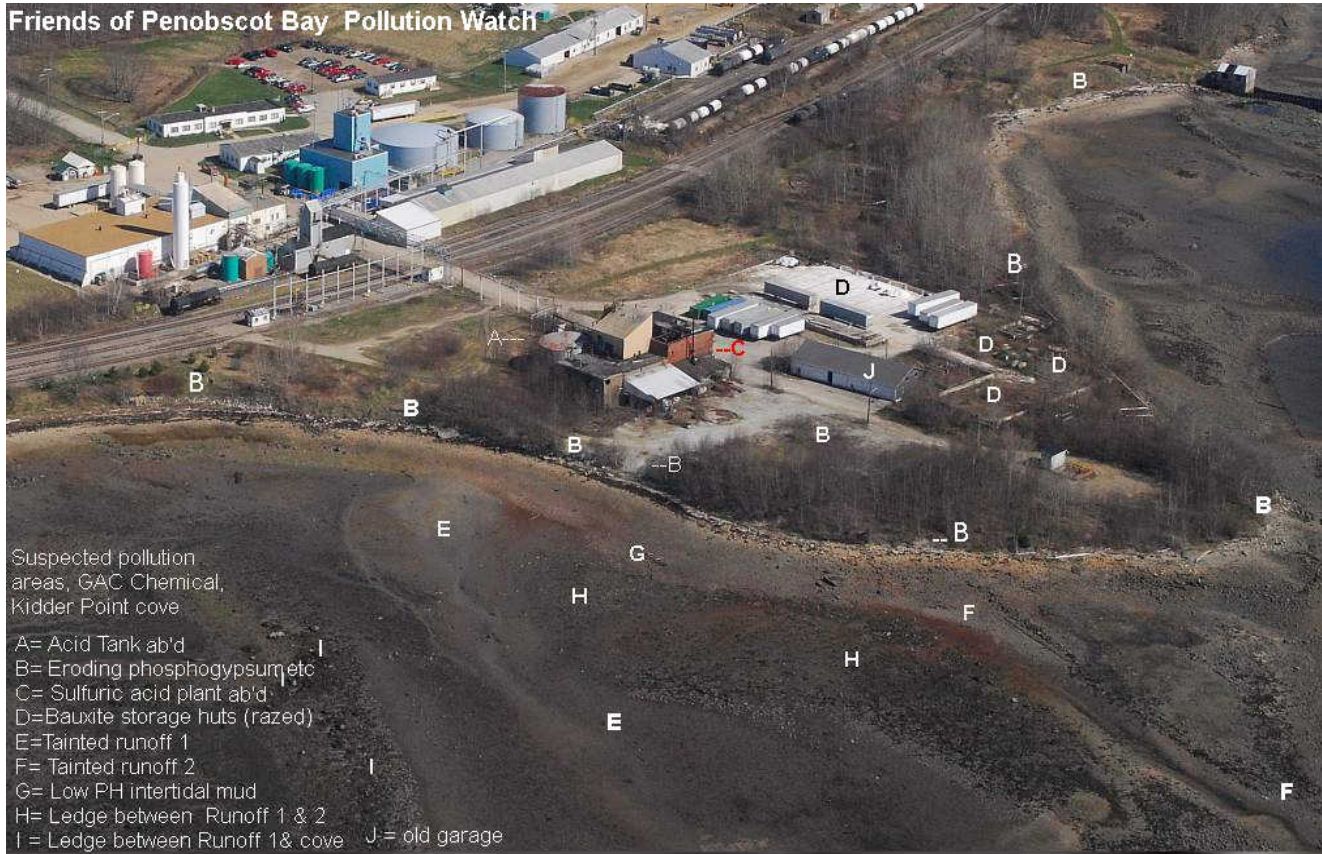
Suspected pollution areas, GAC Chemical, Kidder Point cove

- A= Acid Tank ab'd
- B= Eroding phosphogypsum etc
- C= Sulfuric acid plant ab'd
- D=Bauxite storage huts (razed)
- E=Tainted runoff 1
- F= Tainted runoff 2
- G= Low PH intertidal mud
- H= Ledge between Runoff 1 & 2
- I = Ledge between Runoff 1& cove
- J= old garage

Kidder Point, Maine industrial waste sites from 1905-1970 superphosphate & alum production. 5/1/13. Lighthawk photo.
